## General Information

Date & Time: 04, Nov, 2025 15:03

Make	Mitsubishi	Model	Mirage
YOM	2013	Odo Meter Reading	86,400
Registration No.	WFO822	Chassis No.	MMBXTA03ADH012479
CC	1.2	Transmission	A/T
Fuel Type	Gas	Type of Body	Hatchback
Colour	Gray

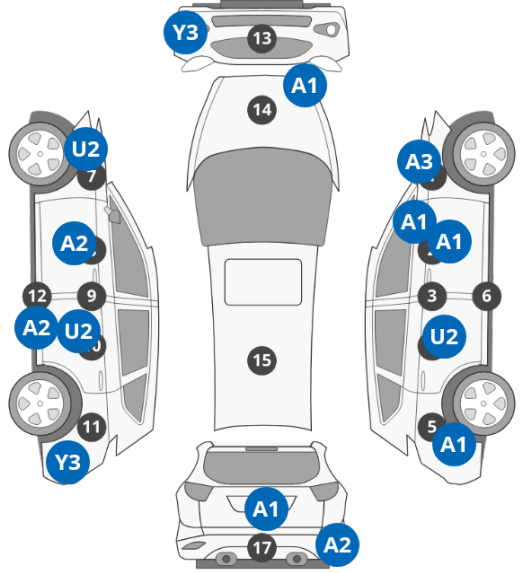
<p><b>A</b> : Scratch <b>AU</b> : Scratch &amp; Dent <b>B</b> : Modified <b>C</b> : Corrosion <b>G</b> : Stone chip <b>P</b> : Faded <b>S</b> : Rust <b>SC</b> : Rust &amp; Corrosion <b>U</b> : Dent <b>X</b> : Defective <b>Y</b> : Crack, Gap</p>
<p><b>Remarks</b> (L) Front Seat - Grime - Medium / Trunk Room - Worn, Scratch, Cut, Crack - Small / Rear Seat - Grime - Medium / (R) Front Seat - Grime - Medium / Dashboard - Worn, Scratch, Cut, Crack - Small / Ceiling - Grime - Small / Console, Switches, Vents - Worn, Scratch, Cut, Crack - Small</p>	<p><b>Remarks</b> (R) Front Door - Repair Traces - Yes / (R) Front Fender - Repair Traces - Yes / Bonnet - Repair Traces - Yes / (L) Front Fender - Repair Traces - Yes / Trunk Hood, Rear Gate - Repair Traces - Yes / (R) Rear Fender - Repair Traces - Yes / (R) Rear Door - Repair Traces - Yes / (L) Rear Door, Molding - Dent - Small / (L) Front Door, Molding - Scratch - Small / (L) Front Fender, Molding - Dent - Small / Bonnet, Headlight - Scratch - Minimal / (R) Front Fender, Molding - Scratch - Medium / (R) Rear Door, Molding - Dent - Small / (R) Mirror - Scratch - Minimal / (R) Front Door, Molding - Scratch - Minimal / (R) Rear Fender, Molding - Scratch - Minimal / Rear Bumper, Lamps, Panels - Scratch - Small / Trunk Hood, Rear Gate - Scratch - Minimal / (L) Rear Fender, Molding - Crack, Gap - Medium / (L) Step, In-panel, Side Spoiler - Scratch - Small / Front Bumper, Grille, Lamps - Crack, Gap - Medium</p>
