## General Information

| Make | Toyota | Model | Avanza |
| Registration No. | FAF7437 | Chassis No. | MHKM5EF2FMK028140 |

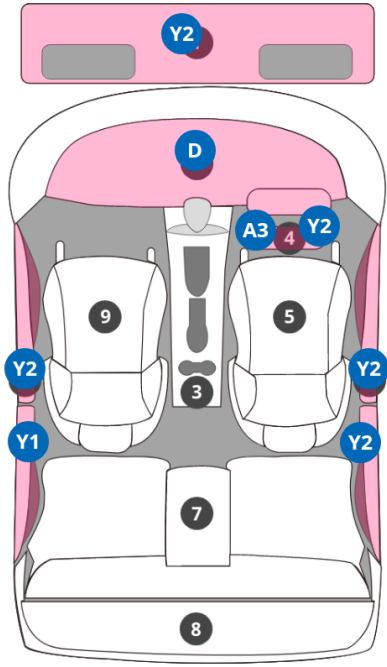
| <b>Remarks</b><br>(R) Front Trim - Grime - Small / (R) Front Floor Mat - Grime - Small / (R) Rear Trim - Grime - Small / (L) Rear Trim - Grime - Minimal / (L) Front Trim - Grime - Small / (L) Front Floor Mat - Cut, Crack - Medium / Dashboard - Traces of Adhesive Tape - Yes / Ceiling - Grime - Small | <b>Remarks</b><br>(R) Front Door - Repair Traces - Yes / (R) Front Fender - Repair Traces - Yes / (L) Rear Door - Repair Traces - Yes / (R) Rear Fender - Repair Traces - Yes / (R) Rear Door - Repair Traces - Yes / Roof - Repair Traces - Yes / (R) Rear Door, Molding - Scratch - Small / (R) Front Door, Molding - Scratch - Minimal / (R) Rear Fender, Molding - Scratch - Minimal / (L) Front Door, Molding - Scratch - Minimal |
