General Information

| Make | Toyota | Model | Vios |
| Registration No. | FAI9605 | Chassis No. | PA1B18F33M4165257 |

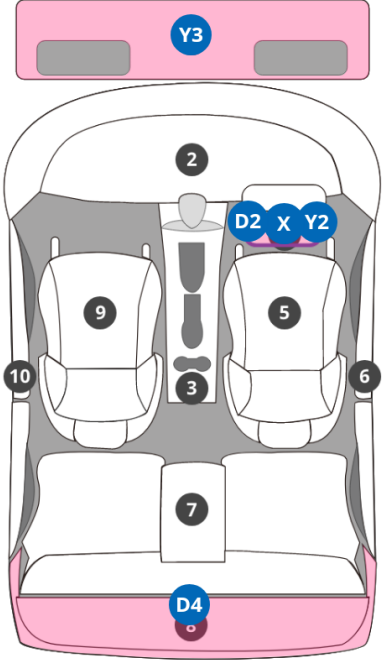
| Interior Evaluation : C | Exterior Evaluation : D |
| <p>Remarks Ceiling - Grime - Medium / (R) Front Floor Mat - Grime - Small / Mat Other - Missing - Yes / (L) Front Floor Mat - Worked - Small / Trunk Room - Worked - Large</p> | <p>Remarks (R) Rear Fender, Molding - Repair mark - Yes / (R) Front Fender, Molding - Scratch & Dent - Medium / (R) Front Door, Molding - Scratch - Medium / (R) Rear Door, Molding - Scratch - Small / Trunk Hood, Rear Gate - Dent - Small / Rear Bumper, Lamps, Panels - Repair mark - Yes / Rear Bumper, Lamps, Panels - Scratch & Dent - Medium / (L) Rear Fender, Molding - Scratch - Small / (L) Rear Door, Molding - Scratch - Small / (L) Front Door, Molding - Scratch - Small / (L) Mirror - Scratch - Minimal / (L) Front Fender, Molding - Scratch - Small / Bonnet, Headlight - Scratch & Dent - Minimal / Front Bumper, Grille, Lamps - Scratch & Dent - Small</p> |

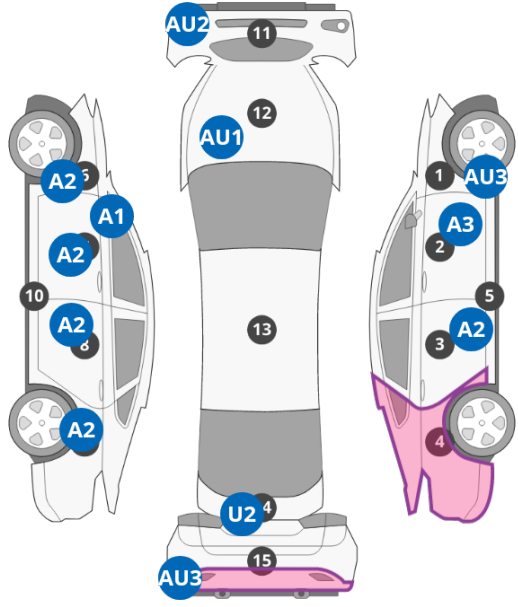
| <p>Rear right fender repaired. Trunk floor partially missing. Possible flooding. Without warranty booklet and tools. With spare tire, jack and leather seat cover. 1 key. With LTO plate.</p> |
