## General Information

<b>Make</b>	Toyota	<b>Model</b>	Vios
<b>YOM</b>	2025	<b>Odo Meter Reading</b>	18,923
<b>Registration No.</b>	NJA2062	<b>Chassis No.</b>	PA1B18F37R4277552
<b>CC</b>	1.3	<b>Transmission</b>	CVT
<b>Fuel Type</b>	Gas	<b>Type of Body</b>	Sedan
<b>Colour</b>	Silver

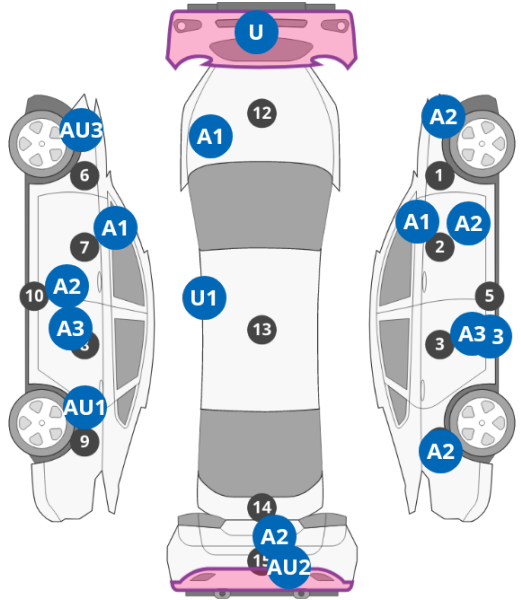
<p><b>A</b> : Scratch <b>AU</b> : Scratch &amp; Dent <b>B</b> : Modified <b>C</b> : Corrosion <b>G</b> : Stone chip <b>P</b> : Faded <b>S</b> : Rust <b>SC</b> : Rust &amp; Corrosion <b>U</b> : Dent <b>X</b> : Defective <b>Y</b> : Crack, Gap</p>
<p><b>Remarks</b> (R) Front Seat - Grime - Medium / (L) Front Seat - Worn - Yes / (L) Front Floor Mat - Worked - Large / (R) Front Trim - Grime - Minimal / (L) Front Trim - Grime - Minimal / Rear Seat - Grime - Small / Ceiling - Grime - Minimal / (R) Front Floor Mat - Worked - Small / (L) Front Floor Mat - Cut, Crack - Small / Dashboard - Traces of Adhesive Tape - Yes</p>	<p><b>Remarks</b> (R) Front Fender, Molding - Scratch - Small / (R) Mirror - Scratch - Minimal / (R) Step, In-panel, Side Spoiler - Scratch - Medium / (R) Rear Door, Molding - Scratch - Medium / (R) Front Door, Molding - Scratch - Small / (R) Rear Fender, Molding - Scratch - Small / Rear Bumper, Lamps, Panels - Repair mark - Yes / Rear Bumper, Lamps, Panels - Scratch &amp; Dent - Small / Trunk Hood, Rear Gate - Scratch - Small / (L) Rear Fender, Molding - Scratch &amp; Dent - Minimal / (L) Rear Door, Molding - Scratch - Medium / (L) Front Door, Molding - Scratch - Small / (L) Mirror - Scratch - Minimal / (L) Front Fender, Molding - Scratch &amp; Dent - Medium / Member (Bolted) - Dent - Yes / Front Bumper, Grille, Lamps - Repair mark - Yes / Front Bumper, Grille, Lamps - Crack, Gap - Medium / Bonnet, Headlight - Scratch - Minimal / Roof - Dent - Minimal</p>
