## General Information

<b>Make</b>	Toyota	<b>Model</b>	Vios
<b>YOM</b>	2025	<b>Odo Meter Reading</b>	42,935
<b>Registration No.</b>	NKE6023	<b>Chassis No.</b>	PA1B18F31R4265378
<b>CC</b>	1.3	<b>Transmission</b>	CVT
<b>Fuel Type</b>	Gas	<b>Type of Body</b>	Sedan
<b>Colour</b>	Blue

## Body / Panel Condition

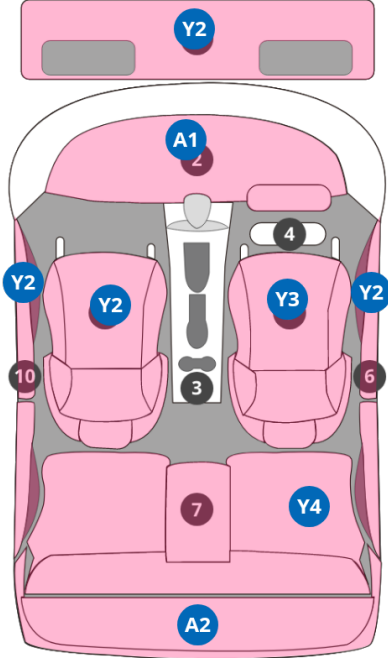
<p><b>a</b> : Cut, Fray <b>d</b> : Loose, Deformed <b>k</b> : Animal Hair <b>s</b> : Smell <b>t</b> : Cigarette Burns <b>x</b> : Defective <b>y</b> : Stain</p>

<p><b>A</b> : Scratch <b>AU</b> : Scratch &amp; Dent <b>B</b> : Modified <b>C</b> : Corrosion <b>G</b> : Stone chip <b>P</b> : Faded <b>S</b> : Rust <b>SC</b> : Rust &amp; Corrosion <b>U</b> : Dent <b>X</b> : Defective <b>Y</b> : Crack, Gap</p>
<p><b>Remarks</b> Rear Seat - Grime - Large / (R) Front Trim - Grime - Small / (R) Front Seat - Grime - Medium / Trunk Room - Worn, Scratch, Cut, Crack - Small / (L) Front Trim - Grime - Small / (L) Front Seat - Grime - Small / Ceiling - Grime - Small / Dashboard - Worn, Scratch, Cut, Crack - Minimal</p>	<p><b>Remarks</b> (L) Front Fender - Repair Traces - Yes / (R) Rear Fender - Repair Traces - Yes / (L) Front Door, Molding - Dent - Medium / (L) Rear Door, Molding - Scratch &amp; Dent - Medium / (L) Rear Fender, Molding - Dent - Large / (L) Front Fender, Molding - Repair mark - Yes / Bonnet, Headlight - Scratch - Minimal / (R) Front Fender, Molding - Scratch - Medium / (R) Front Door, Molding - Scratch - Medium / (R) Rear Door, Molding - Scratch &amp; Dent - Small / (R) Rear Fender, Molding - Scratch - Minimal / Trunk Hood, Rear Gate - Scratch - Medium / Rear Bumper, Lamps, Panels - Scratch - Small / Roof - Scratch - Minimal / (L) Step, In-panel, Side Spoiler - Scratch - Small / (L) Front Fender, Molding - Scratch - Minimal</p>
