## General Information

Date & Time: 05, Nov, 2025 10:36

<b>Make</b>	Toyota	<b>Model</b>	Vios
<b>YOM</b>	2023	<b>Odo Meter Reading</b>	46,120
<b>Registration No.</b>	NFA2492	<b>Chassis No.</b>	PA1B18F35P4204869
<b>CC</b>	1.3	<b>Transmission</b>	CVT
<b>Fuel Type</b>	Gas	<b>Type of Body</b>	Sedan
<b>Colour</b>	Silver

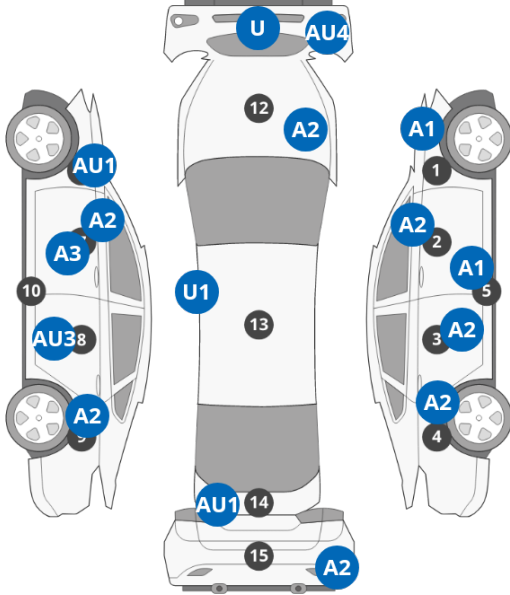
<p><b>A</b> : Scratch <b>AU</b> : Scratch &amp; Dent <b>B</b> : Modified <b>C</b> : Corrosion <b>G</b> : Stone chip <b>P</b> : Faded <b>S</b> : Rust <b>SC</b> : Rust &amp; Corrosion <b>U</b> : Dent <b>X</b> : Defective <b>Y</b> : Crack, Gap</p>
<p><b>Remarks</b> Rear Seat - Worn - Yes / (L) Front Seat - Worn - Yes / (R) Front Seat - Grime - Medium / (R) Front Trim - Grime - Minimal / (L) Front Trim - Grime - Minimal / Ceiling - Grime - Minimal</p>	<p><b>Remarks</b> (R) Front Fender, Molding - Scratch - Minimal / (R) Mirror - Scratch - Small / (R) Rear Door, Molding - Scratch - Small / (R) Front Door, Molding - Scratch - Minimal / (R) Rear Fender, Molding - Scratch - Small / Rear Bumper, Lamps, Panels - Scratch - Small / Trunk Hood, Rear Gate - Scratch &amp; Dent - Minimal / (L) Rear Fender, Molding - Scratch - Small / (L) Rear Door, Molding - Scratch &amp; Dent - Medium / (L) Front Door, Molding - Scratch - Medium / (L) Mirror - Scratch - Small / (L) Front Fender, Molding - Scratch &amp; Dent - Minimal / Member (Bolted) - Dent - Yes / Bonnet, Headlight - Scratch - Small / Front Bumper, Grille, Lamps - Scratch &amp; Dent - Large / Roof - Dent - Minimal</p>
