## General Information

<b>Make</b>	Toyota	<b>Model</b>	Vios
<b>YOM</b>	2024	<b>Odo Meter Reading</b>	41,880
<b>Registration No.</b>	NEY5736	<b>Chassis No.</b>	PA1B18F37R4256703
<b>CC</b>	1.3	<b>Transmission</b>	CVT
<b>Fuel Type</b>	Gas	<b>Type of Body</b>	Sedan
<b>Colour</b>	Red

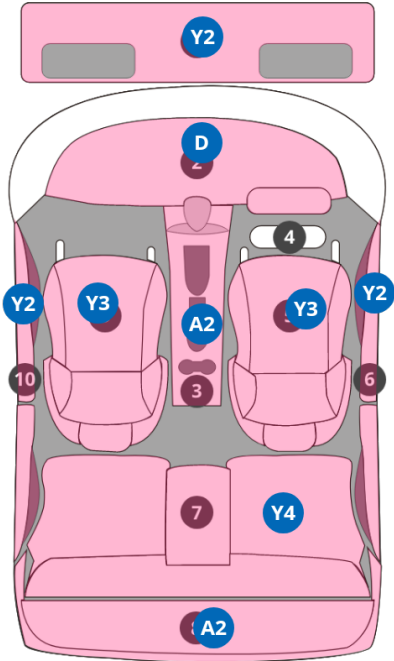
<b>Interior Evaluation :</b> <span style="float: right; color: red; font-weight: bold;">C</span>	<b>Exterior Evaluation :</b> <span style="float: right; color: red; font-weight: bold;">C</span>

<p><b>a</b> : Cut, Fray <b>d</b> : Loose, Deformed <b>k</b> : Animal Hair <b>s</b> : Smell <b>t</b> : Cigarette Burns <b>x</b> : Defective <b>y</b> : Stain</p>

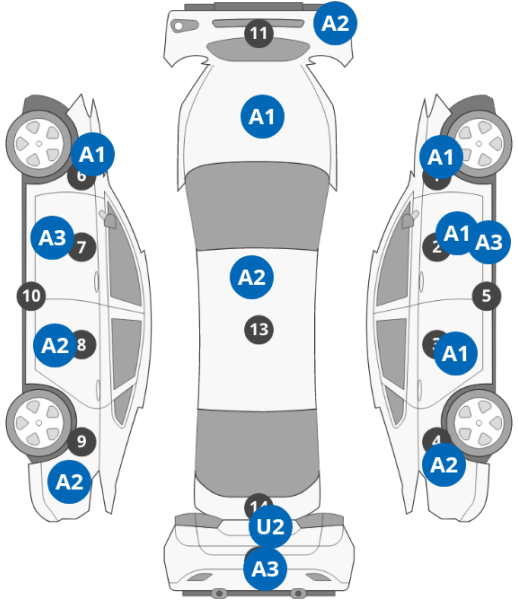
<p><b>A</b> : Scratch <b>AU</b> : Scratch &amp; Dent <b>B</b> : Modified <b>C</b> : Corrosion <b>G</b> : Stone chip <b>P</b> : Faded <b>S</b> : Rust <b>SC</b> : Rust &amp; Corrosion <b>U</b> : Dent <b>X</b> : Defective <b>Y</b> : Crack, Gap</p>
<p><b>Remarks</b> (R) Front Seat - Grime - Medium / (R) Front Trim - Grime - Small / Rear Seat - Grime - Large / (L) Front Trim - Grime - Small / (L) Front Seat - Grime - Medium / Dashboard - Traces of Adhesive Tape - Yes / Ceiling - Grime - Small / Console, Switchs, Vents - Worn, Scratch, Cut, Crack - Small / Trunk Room - Worn, Scratch, Cut, Crack - Small</p>	<p><b>Remarks</b> (L) Front Fender, Molding - Scratch - Minimal / (L) Front Door, Molding - Scratch - Medium / (L) Rear Door, Molding - Scratch - Small / (L) Rear Fender, Molding - Scratch - Small / Trunk Hood, Rear Gate - Dent - Small / Rear Bumper, Lamps, Panels - Scratch - Medium / (R) Rear Fender, Molding - Scratch - Small / (R) Step, In-panel, Side Spoiler - Scratch - Medium / (R) Rear Door, Molding - Scratch - Minimal / (R) Front Door, Molding - Scratch - Minimal / (R) Front Fender, Molding - Scratch - Minimal / Front Bumper, Grille, Lamps - Scratch - Small / Bonnet, Headlight - Scratch - Minimal / Roof - Scratch - Small</p>
