## General Information

| Make | Toyota | Model | Vios |
| Registration No. | DBI3101 | Chassis No. | PA1B18F31P4213326 |

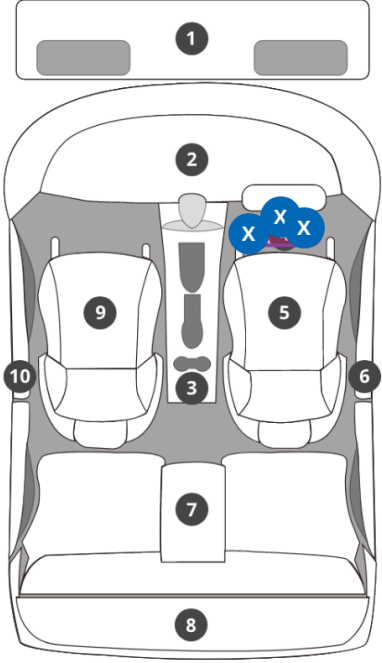
| Interior Evaluation : <b>B</b> | Exterior Evaluation : <b>D</b> |
|---|---|
| <p><b>Remarks</b></p> <p>(R) Front Floor Mat - Missing - Yes / (L) Front Floor Mat - Missing - Yes / Mat Other - Missing - Yes</p> | <p><b>Remarks</b></p> <p>(R) Front Fender, Molding - Scratch &amp; Dent - Large / Bonnet, Headlight - Scratch &amp; Dent - Large / Front Bumper, Grille, Lamps - Scratch &amp; Dent - Large / (R) Mirror - Scratch, Peeled - Yes / (L) Rear Fender, Molding - Dent - Minimal / Rear Bumper, Lamps, Panels - Scratch - Large / (R) Step, In-panel, Side Spoiler - Crack, Gap - Medium / (R) Front Door, Molding - Scratch &amp; Dent - Medium</p> |
