## General Information

<b>Make</b>	Toyota	<b>Model</b>	Avanza
<b>YOM</b>	2018	<b>Odo Meter Reading</b>	67,114
<b>Registration No.</b>	GAD1146	<b>Chassis No.</b>	MHKM5EE2FHK008212
<b>CC</b>	1.3	<b>Transmission</b>	M/T
<b>Fuel Type</b>	Gas	<b>Type of Body</b>	Wagon
<b>Colour</b>	Silver

## Body / Panel Condition

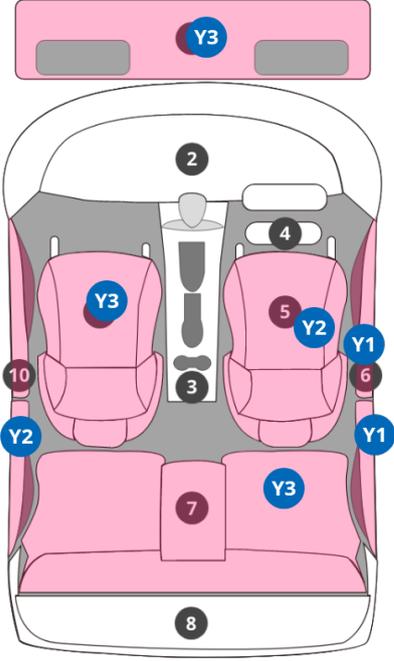
<b>Interior Evaluation :</b> <span style="float: right; color: red; font-weight: bold;">B</span>	<b>Exterior Evaluation :</b> <span style="float: right; color: red; font-weight: bold;">D</span>

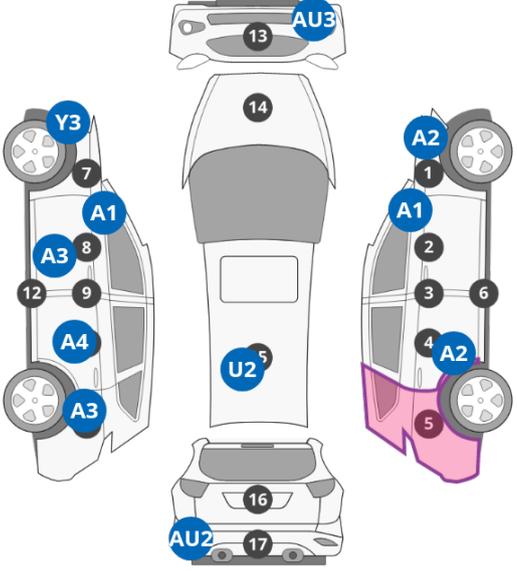
<p><b>A</b> : Scratch <b>AU</b> : Scratch &amp; Dent <b>B</b> : Modified <b>C</b> : Corrosion <b>G</b> : Stone chip <b>P</b> : Faded <b>S</b> : Rust <b>SC</b> : Rust &amp; Corrosion <b>U</b> : Dent <b>X</b> : Defective <b>Y</b> : Crack, Gap</p>
<p><b>Remarks</b> Ceiling - Grime - Medium / (R) Front Seat - Grime - Small / Rear Seat - Grime - Medium / (R) Rear Trim - Grime - Minimal / (R) Front Trim - Grime - Minimal / (L) Rear Trim - Grime - Small / (L) Front Seat - Grime - Medium</p>	<p><b>Remarks</b> (R) Rear Fender - Repair Traces - Yes / (R) Mirror - Scratch - Minimal / (R) Rear Door, Molding - Scratch - Small / (R) Rear Fender, Molding - Repair mark - Yes / Rear Bumper, Lamps, Panels - Scratch &amp; Dent - Small / (L) Rear Fender, Molding - Scratch - Medium / (L) Rear Door, Molding - Scratch - Large / (L) Front Door, Molding - Scratch - Medium / (L) Mirror - Scratch - Minimal / (L) Front Fender, Molding - Crack, Gap - Medium / Front Bumper, Grille, Lamps - Scratch &amp; Dent - Medium / (R) Front Fender, Molding - Scratch - Small / Roof - Dent - Small</p>
