General Information

Make	Mitsubishi	Model	Mirage
YOM	2023	Odo Meter Reading	23,581
Registration No.	LAL2399	Chassis No.	PAEA13TJPNA002537
CC	1.2	Transmission	A/T
Fuel Type	Gas	Type of Body	Sedan
Colour	Silver

Body / Panel Condition

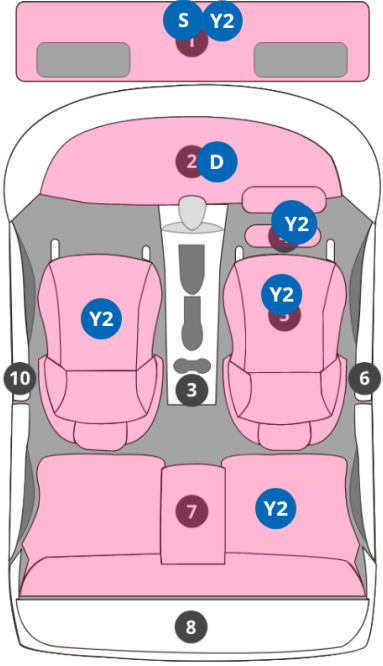
Interior Evaluation : B	Exterior Evaluation : E

<p>A : Scratch AU : Scratch & Dent B : Modified C : Corrosion G : Stone chip P : Faded S : Rust SC : Rust & Corrosion U : Dent X : Defective Y : Crack, Gap</p>
Remarks (L) Front Floor Mat - Worked - Small / Ceiling - Grime - Small / Overall Interior - Smell - Yes / Dashboard - Traces of Adhesive Tape - Yes / (R) Front Floor Mat - Grime - Small / (L) Front Seat - Grime - Small / (R) Front Seat - Grime - Small / Rear Seat - Grime - Small	Remarks (R) Front Door - Repair Traces - Yes / (R) Step - Repair Traces - Yes / (R) Front Fender - Repair Traces - Yes / Bonnet - Repair Traces - Yes / (L) Front Fender - Repair Traces - Yes / (L) Front Door - Repair Traces - Yes / (L) Step - Repair Traces - Yes / (L) Rear Door - Repair Traces - Yes / (L) Rear Fender - Repair Traces - Yes / Trunk Hood, Rear Gate - Repair Traces - Yes / Rear End Panel - Repair Traces - Yes / (R) Rear Fender - Repair Traces - Yes / (R) Rear Fender - Replaced - Yes / (R) Rear Door - Repair Traces - Yes / Roof - Repair Traces - Yes / Trunk Hood, Rear Gate - Repair mark - Yes / (L) Rear Fender, Molding - Repair mark - Yes / (L) Rear Door, Molding - Repair mark - Yes / (L) Front Door, Molding - Repair mark - Yes / (R) Front Door, Molding - Repair mark - Yes / (R) Rear Door, Molding - Repair mark - Yes / (L) Front Fender, Molding - Repair mark - Yes / (R) Front Fender, Molding - Repair mark - Yes / Bonnet, Headlight - Repair mark - Yes / Member (Bolted) - Dent - Yes / Roof - Repair mark - Yes / Overall Exterior - Full Re-Paint in same color - Yes / (L) Front Fender, Molding - Scratch & Dent - Large / (L) Front Door, Molding - Scratch - Small / (L) Rear Door, Molding - Scratch & Dent - Small / (L) Step, In-panel, Side Spoiler - Scratch & Dent - Small / (L) Step, In-panel, Side Spoiler - Repair mark - Yes / (R) Step, In-panel, Side Spoiler - Repair mark - Yes / (L) Mirror - Scratch - Minimal / Bonnet, Headlight - Scratch & Dent - Small / Roof - Scratch & Dent - Small / (R) Front Fender, Molding - Scratch - Small / (R) Front Door, Molding - Scratch - Small / (R) Rear Door, Molding - Scratch - Small / (R) Rear Fender, Molding - Scratch & Dent - Small / (R) Step, In-panel, Side Spoiler - Scratch & Dent - Small / Trunk Hood, Rear Gate - Scratch - Small / Rear Bumper, Lamps, Panels - Scratch - Small
