## General Information

| Make | Suzuki | Model | Ertiga |
| Registration No. | FDM7368 | Chassis No. | MHYZE8153HJ301225 |

## Overall Evaluation :

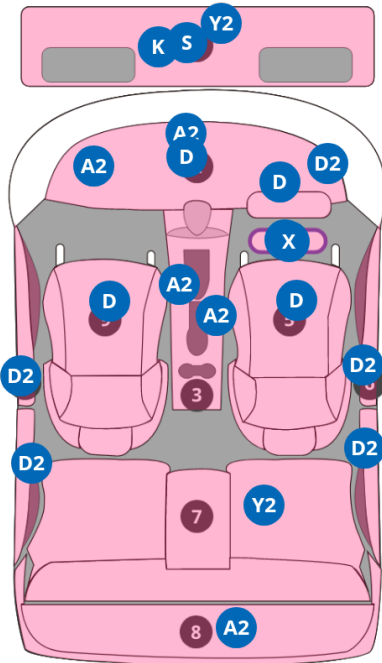
| Interior Evaluation : <span style="color: red;">D</span> | Exterior Evaluation : <span style="color: red;">E</span> |
|---|---|
| <b>Remarks</b><br>Overall Interior - Worn as per age - Yes / Overall Interior - Smell - Yes / Overall Interior - Animal Hair - Yes / Ceiling - Grime - Small / (L) Front Trim - Loose, Deformed - Small / (L) Front Seat - Worn - Yes / (R) Front Seat - Worn - Yes / (L) Front Floor Mat - Missing - Yes / (R) Front Floor Mat - Missing - Yes / Rear Seat - Grime - Small / Console, Switchs, Vents - Worn, Scratch, Cut, Crack - Small / Knobs - Worn, Peel, Crack - Small / Display, Audio System - Stuck - Yes / Dashboard - Worn, Scratch, Cut, Crack - Small / Dashboard - Traces of Adhesive Tape - Yes / Steering Wheel - Worn, Peel, Crack - Small / Glove Box - Loose, Deformed - Small / Glove Box - Traces of Adhesive Tape - Yes / Trunk Room - Worn, Scratch, Cut, Crack - Small / (R) Front Trim - Loose, Deformed - Small / (L) Rear Trim - Worked - Small / (R) Rear Trim - Worked - Small | <b>Remarks</b><br>(R) Front Door - Repair Traces - Yes / (R) Step - Repair Traces - Yes / (R) Step - Replaced - Yes / (R) Front Fender - Repair Traces - Yes / Bonnet - Repair Traces - Yes / (L) Front Fender - Repair Traces - Yes / (L) Front Door - Repair Traces - Yes / (L) Step - Repair Traces - Yes / (L) Step - Replaced - Yes / (L) Rear Door - Repair Traces - Yes / (L) Rear Fender - Repair Traces - Yes / Trunk Hood, Rear Gate - Repair Traces - Yes / Rear End Panel - Replaced - Yes / (R) Rear Fender - Repair Traces - Yes / (R) Rear Door - Repair Traces - Yes / Roof - Repair Traces - Yes / Roof - Replaced - Yes / Trunk Hood, Rear Gate - Repair mark - Yes / (L) Rear Fender, Molding - Repair mark - Yes / (L) Rear Door, Molding - Repair mark - Yes / (L) Front Door, Molding - Repair mark - Yes / Bonnet, Headlight - Repair mark - Yes / (L) Front Fender, Molding - Repair mark - Yes / (R) Front Fender, Molding - Repair mark - Yes / (R) Rear Door, Molding - Repair mark - Yes / (R) Front Door, Molding - Repair mark - Yes / (R) Rear Fender, Molding - Repair mark - Yes / (L) Front Fender, Molding - Scratch - Small / (L) Front Door, Molding - Scratch & Dent - Small / (L) Rear Door, Molding - Scratch & Dent - Small / (L) Step, In-panel, Side Spoiler - Scratch & Dent - Small / (L) Rear Fender, Molding - Scratch - Small / Bonnet, Headlight - Scratch - Small / Front Bumper, Grille, Lamps - Repair mark - Yes / Front Bumper, Grille, Lamps - Scratch - Large / Overall Exterior - Full Re-Paint in same color - Yes / (R) Front Fender, Molding - Scratch - Small / (L) Mirror - Scratch - Minimal / (R) Mirror - Scratch - Minimal / (R) Front Door, Molding - Scratch - Small / (R) Rear Door, Molding - Scratch & Dent - Small / (R) Rear Fender, Molding - Scratch - Small / Roof - Scratch & Dent - Small / Trunk Hood, Rear Gate - Scratch - Small / Rear Bumper, Lamps, Panels - Scratch - Small / (R) Step, In-panel, Side Spoiler - Scratch & Dent - Small |

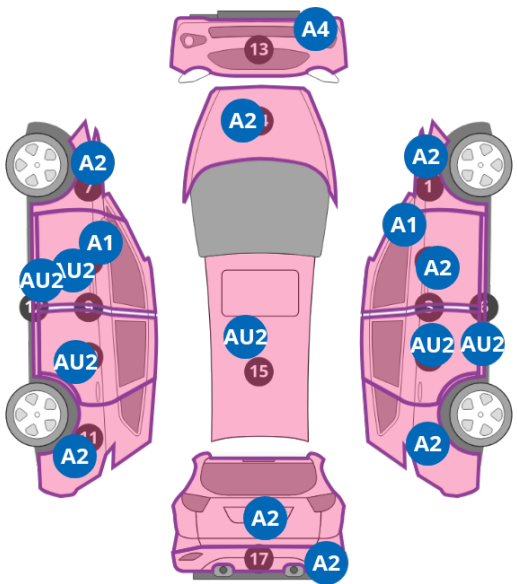
With LTO plate and Sparetire, No Tools and Jack and Warranty booklet, scratch and crack tail light and headlight, worn tires and Sparetire, No spare key, no reverse camera, foul smell, possible flooded, warning lamps on, headlight worn and tail light worn, adhesive marks on vehicle.
