General Information

| Make | Toyota | Model | Vios |
| Registration No. | DBH8635 | Chassis No. | PA1B18F37P4209653 |

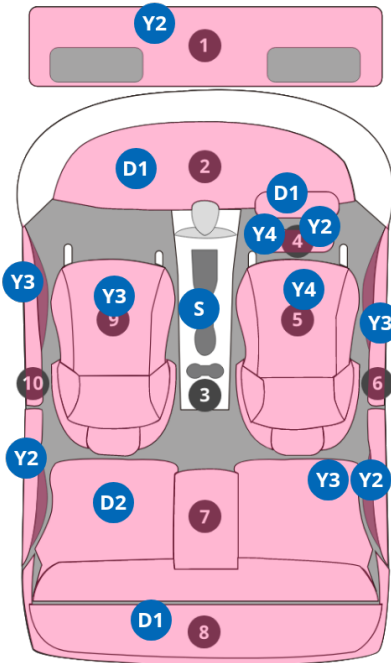
| Interior Evaluation : E | Exterior Evaluation : E |
| <p>Remarks Ceiling - Grime - Small / (L) Front Trim - Grime - Medium / (L) Front Seat - Grime - Medium / (L) Front Floor Mat - Grime - Large / Dashboard - Worked - Minimal / (L) Rear Trim - Grime - Small / Trunk Room - Worked - Minimal / Rear Seat - Grime - Medium / (R) Rear Trim - Grime - Small / (R) Front Trim - Grime - Medium / (R) Front Seat - Grime - Large / (R) Front Floor Mat - Grime - Small / Glove Box - Worked - Minimal / Overall Interior - Smell - Yes / Rear Seat Head Rest - Worked - Small</p> | <p>Remarks Trunk Hood, Rear Gate - Repair Traces - Yes / Front Bumper, Grille, Lamps - Scratch & Dent - Small / Front Bumper, Grille, Lamps - Repair mark - Yes / (L) Front Fender, Molding - Scratch & Dent - Small / (L) Front Door, Molding - Scratch & Dent - Small / (L) Rear Door, Molding - Scratch & Dent - Small / (L) Rear Door, Molding - Scratch & Dent - Small / (L) Rear Fender, Molding - Scratch & Dent - Small / Trunk Hood, Rear Gate - Scratch & Dent - Medium / Rear Bumper, Lamps, Panels - Scratch - Medium / Overall Exterior - Full Re-Paint in same color - Yes / (R) Rear Fender, Molding - Scratch & Dent - Small / (R) Rear Door, Molding - Scratch & Dent - Small / (R) Front Door, Molding - Scratch & Dent - Small / (R) Front Door, Molding - Repair mark - Yes / (R) Front Fender, Molding - Scratch & Dent - Small / Bonnet, Headlight - Scratch & Dent - Small / (L) Step, In-panel, Side Spoiler - Scratch & Dent - Small / (R) Step, In-panel, Side Spoiler - Scratch & Dent - Small / Roof - Scratch & Dent - Small</p> |
