General Information

Date & Time: 08, Nov, 2025 09:00

Make	Honda	Model	City
YOM	2018	Odo Meter Reading	70,512
Registration No.	NBC2609	Chassis No.	PADGM6620JV408911
CC	1.5	Transmission	A/T
Fuel Type	Gas	Type of Body	Sedan
Colour	White

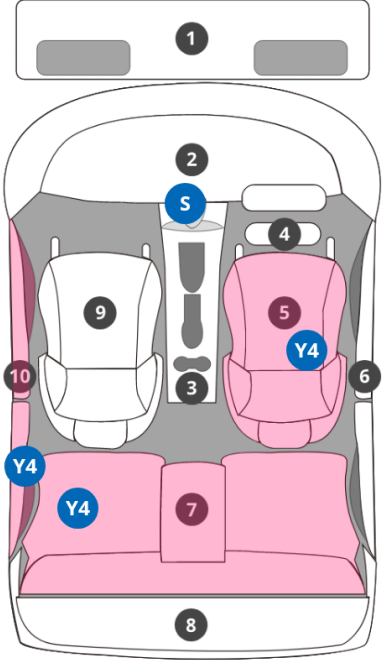
Interior Evaluation : C	Exterior Evaluation : E

<p>A : Scratch AU : Scratch & Dent B : Modified C : Corrosion G : Stone chip P : Faded S : Rust SC : Rust & Corrosion U : Dent X : Defective Y : Crack, Gap</p>
<p>Remarks (L) Rear Trim - Grime - Large / Rear Seat - Grime - Large / (R) Front Seat - Grime - Large / Overall Interior - Smell - Yes</p>	<p>Remarks (R) Front Fender - Repair Traces - Yes / Trunk Hood, Rear Gate - Modified - Large / (L) Step, In-panel, Side Spoiler - Repair mark - Yes / (L) Rear Fender, Molding - Repair mark - Yes / (L) Front Fender, Molding - Repair mark - Yes / Front Bumper, Grille, Lamps - Repair mark - Yes / (L) Front Fender, Molding - Modified - Small / Front Bumper, Grille, Lamps - Scratch - Large / (L) Front Door, Molding - Repair mark - Yes / (L) Rear Door, Molding - Repair mark - Yes / (R) Rear Fender, Molding - Repair mark - Yes / Trunk Hood, Rear Gate - Repair mark - Yes / Rear Bumper, Lamps, Panels - Repair mark - Yes / Rear Bumper, Lamps, Panels - Crack, Gap - Large / (R) Rear Fender, Molding - Scratch - Medium / (R) Step, In-panel, Side Spoiler - Scratch & Dent - Medium / (R) Step, In-panel, Side Spoiler - Repair mark - Yes / (R) Rear Door, Molding - Repair mark - Yes / (R) Front Door, Molding - Repair mark - Yes / (R) Front Fender, Molding - Repair mark - Yes / (R) Rear Door, Molding - Scratch - Small / (R) Front Door, Molding - Scratch - Small / (R) Front Fender, Molding - Modified - Small / Bonnet, Headlight - Scratch - Medium</p>
