General Information

Make	Toyota	Model	Avanza
YOM	2025	Odo Meter Reading	9,498
Registration No.	FAS3169	Chassis No.	MHFAA1BYXR0034099
CC	1.3	Transmission	CVT
Fuel Type	Gas	Type of Body	MPV
Colour	Red Mica Metallic

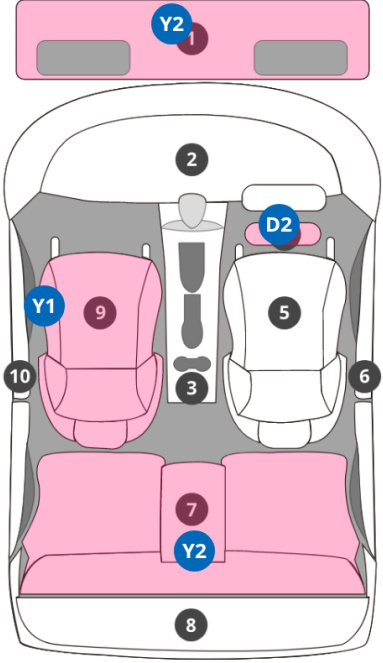
Interior Evaluation : B	Exterior Evaluation : E

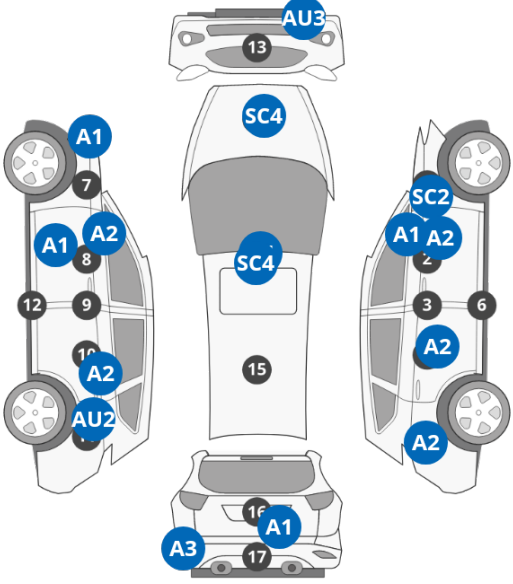
<p>A : Scratch AU : Scratch & Dent B : Modified C : Corrosion G : Stone chip P : Faded S : Rust SC : Rust & Corrosion U : Dent X : Defective Y : Crack, Gap</p>
Remarks Ceiling - Grime - Small / (L) Front Floor Mat - Worked - Small / Rear Seat - Grime - Small / (L) Front Seat - Grime - Minimal / Room Mirror - Missing - Yes	Remarks (R) Front Fender, Molding - Rust, Corrosion - Small / (R) Mirror - Scratch - Minimal / (R) Front Door, Molding - Scratch - Small / (R) Rear Door, Molding - Scratch - Small / (R) Rear Fender, Molding - Scratch - Small / Rear Bumper, Lamps, Panels - Scratch - Medium / Trunk Hood, Rear Gate - Scratch - Minimal / (L) Rear Door, Molding - Scratch - Small / (L) Front Door, Molding - Scratch - Minimal / (L) Mirror - Scratch - Small / (L) Front Fender, Molding - Scratch - Minimal / Bonnet, Headlight - Rust, Corrosion - Large / Front Windshield - Scratch, Stone chip - Large / Front Bumper, Grille, Lamps - Scratch & Dent - Medium / Roof - Rust, Corrosion - Large / (L) Rear Fender, Molding - Scratch & Dent - Small
