General Information

Date & Time: 17, Nov, 2025 18:57

Make	Toyota	Model	Hiace
YOM	2024	Odo Meter Reading	28,308
Registration No.	JAS7066	Chassis No.	JTFJT02P0R0018427
CC	3.0	Transmission	M/T
Fuel Type	Diesel	Type of Body	Van
Colour	White

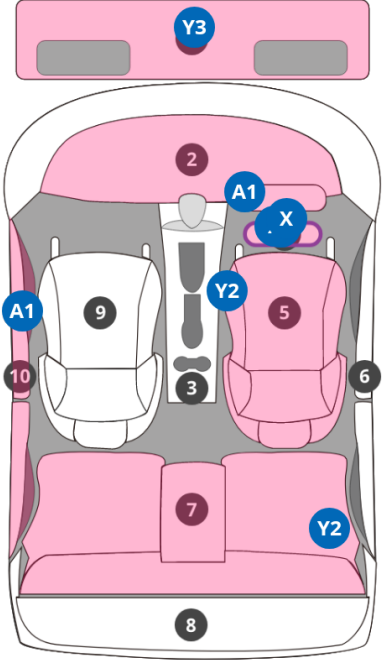
Interior Evaluation : B	Exterior Evaluation : D

<p>a : Cut, Fray d : Loose, Deformed k : Animal Hair s : Smell t : Cigarette Burns x : Defective y : Stain</p>

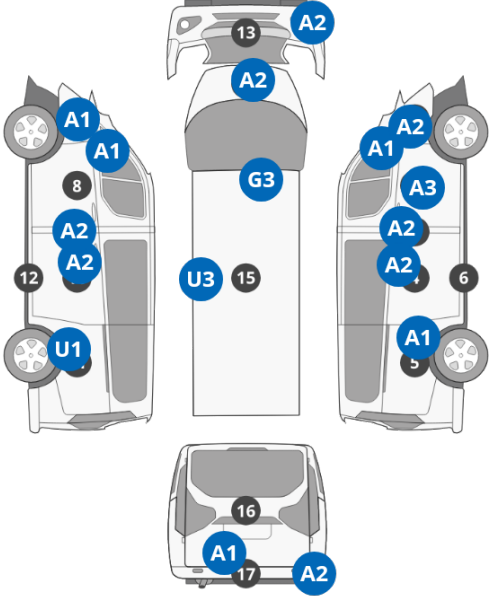
<p>A : Scratch AU : Scratch & Dent B : Modified C : Corrosion G : Stone chip P : Faded S : Rust SC : Rust & Corrosion U : Dent X : Defective Y : Crack, Gap</p>
<p>Remarks Ceiling - Grime - Medium / Mat Other - Missing - Yes / (R) Front Floor Mat - Missing - Yes / (L) Front Floor Mat - Missing - Yes / (R) Front Seat - Grime - Small / Rear Seat - Grime - Small / Dashboard - Worn, Scratch, Cut, Crack - Minimal / (L) Front Trim - Cut, Crack - Minimal</p>	<p>Remarks (R) Front Door, Molding - Scratch - Medium / (R) Mirror - Scratch - Minimal / (R) Front Fender, Molding - Scratch - Small / (R) Center Panel - Scratch - Small / (R) Rear Door, Molding - Scratch - Small / (R) Rear Fender, Molding - Scratch - Minimal / Rear Bumper, Lamps, Panels - Scratch - Small / Trunk Hood, Rear Gate - Scratch - Minimal / (L) Rear Fender, Molding - Dent - Minimal / (L) Rear Door, Molding - Scratch - Small / (L) Front Door, Molding - Scratch - Small / (L) Mirror - Scratch - Minimal / (L) Front Fender, Molding - Scratch - Minimal / Front Panel - Scratch - Small / Front Bumper, Grille, Lamps - Scratch - Small / Front Windshield - Scratch, Stone chip - Medium / Roof - Dent - Medium</p>
