## General Information

<b>Make</b>	Toyota	<b>Model</b>	Vios
<b>YOM</b>	2025	<b>Odo Meter Reading</b>	28,606
<b>Registration No.</b>	GBD8048	<b>Chassis No.</b>	PA1B18F38R4270514
<b>CC</b>	1.3	<b>Transmission</b>	CVT
<b>Fuel Type</b>	Gas	<b>Type of Body</b>	Sedan
<b>Colour</b>	Red Mica Metallic

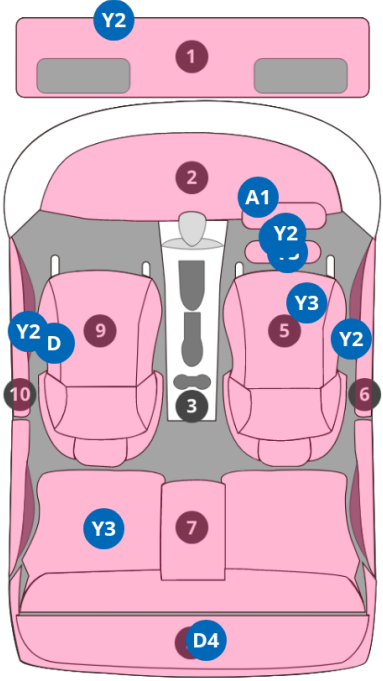
<b>Interior Evaluation :</b> <span style="float: right;"><b>E</b></span>	<b>Exterior Evaluation :</b> <span style="float: right;"><b>D</b></span>

<p><b>a</b> : Cut, Fray <b>d</b> : Loose, Deformed <b>k</b> : Animal Hair <b>s</b> : Smell <b>t</b> : Cigarette Burns <b>x</b> : Defective <b>y</b> : Stain</p>

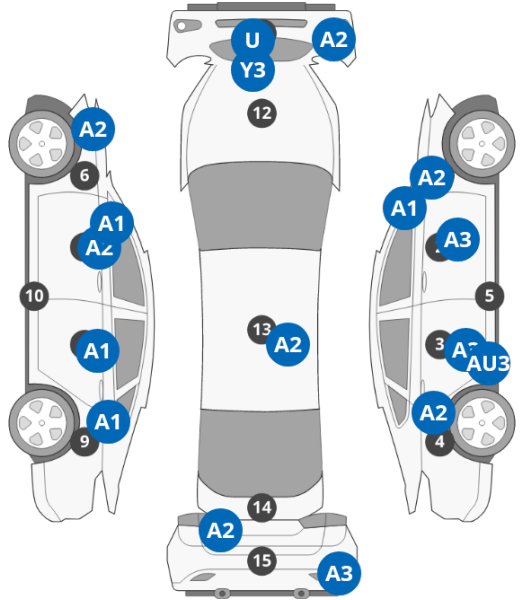
<p><b>A</b> : Scratch <b>AU</b> : Scratch &amp; Dent <b>B</b> : Modified <b>C</b> : Corrosion <b>G</b> : Stone chip <b>P</b> : Faded <b>S</b> : Rust <b>SC</b> : Rust &amp; Corrosion <b>U</b> : Dent <b>X</b> : Defective <b>Y</b> : Crack, Gap</p>
<b>Remarks</b> Trunk Room - Worked - Large / (L) Front Floor Mat - Cut, Crack - Small / (L) Front Seat - Worn - Yes / (R) Front Seat - Grime - Medium / Mat Other - Grime - Medium / Rear Seat - Grime - Medium / (R) Front Trim - Grime - Small / (L) Front Trim - Grime - Small / Ceiling - Grime - Small / (L) Front Floor Mat - Worked - Large / (R) Front Floor Mat - Grime - Small / Glove Box - Worn, Scratch, Cut, Crack - Minimal	<b>Remarks</b> Member (Bolted) - Dent - Yes / (R) Front Fender, Molding - Scratch - Small / (R) Mirror - Scratch - Minimal / (R) Front Door, Molding - Scratch - Medium / (R) Rear Door, Molding - Scratch - Medium / (R) Step, In-panel, Side Spoiler - Scratch & Dent - Medium / (R) Rear Fender, Molding - Scratch - Small / Rear Bumper, Lamps, Panels - Scratch - Medium / Trunk Hood, Rear Gate - Scratch - Small / (L) Rear Fender, Molding - Scratch - Minimal / (L) Front Door, Molding - Scratch - Small / (L) Rear Door, Molding - Scratch - Minimal / (L) Mirror - Scratch - Minimal / (L) Front Fender, Molding - Scratch - Small / Front Bumper, Grille, Lamps - Scratch - Small / Bonnet, Headlight - Crack, Gap - Medium / Roof - Scratch - Small
