General Information

Make	Hino	Model	XZU710LN
YOM	2024	Odo Meter Reading	28,499
Registration No.	NKF7544	Chassis No.	JHHUCP3F3RK056398
CC	4.0	Transmission	M/T
Fuel Type	Diesel	Type of Body	Aluminum Van
Colour	White

Body / Panel Condition

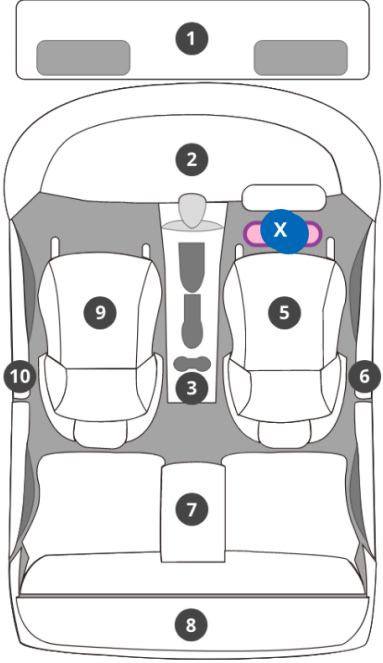
<p>A : Scratch AU : Scratch & Dent B : Modified C : Corrosion G : Stone chip P : Faded S : Rust SC : Rust & Corrosion U : Dent X : Defective Y : Crack, Gap</p>
<p>Remarks (L) Front Floor Mat - Missing - Yes / (R) Front Floor Mat - Missing - Yes</p>	<p>Remarks (L) Side Gate - Scratch - Medium / (L) Front Door, Molding - Scratch - Small / Front Panel - Scratch - Small / (R) Front Fender, Molding - Scratch - Minimal / (L) Front Fender, Molding - Scratch - Small / (R) Front Door, Molding - Scratch - Small / Roof - Scratch & Dent - Small / (R) Side Gate - Scratch - Medium / Rear Gate - Scratch - Medium / Rear Bumper, Lamps, Panels - Scratch - Medium / Cab Back Panel - Scratch - Small / Front Bumper, Grille, Lamps - Scratch - Small</p>
