## General Information

| Make | Toyota | Model | Hilux Tamaraw |
| Registration No. | CDA4662 | Chassis No. | PAHAWAAA0S1340378 |

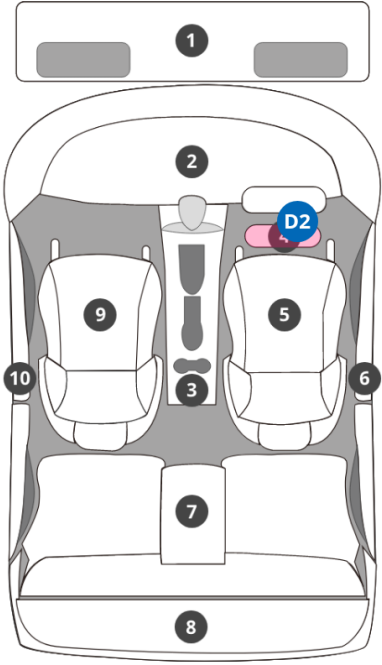
| Interior Evaluation : <span style="color: red; font-weight: bold;">A</span> | Exterior Evaluation : <span style="color: red; font-weight: bold;">C</span> |
| <b>Remarks</b><br>(L) Front Floor Mat - Worked - Small | <b>Remarks</b><br>Bonnet, Headlight - Scratch - Minimal / Front Bumper, Grille, Lamps - Scratch - Small / (R) Front Fender, Molding - Scratch - Minimal / (R) Front Door, Molding - Scratch - Small / (R) Side Gate - Scratch - Small / (R) Rear Wheel, Cover - Cap Missing - Yes / (R) Front Wheel, Cover - Cap Missing - Yes / (L) Rear Wheel, Cover - Cap Missing - Yes / (L) Front Wheel, Cover - Cap Missing - Yes / Rear Gate - Scratch - Small / (L) Side Gate - Scratch & Dent - Small / (L) Front Door, Molding - Scratch - Small / (L) Front Fender, Molding - Scratch - Minimal / (L) Mirror - Scratch - Minimal / Roof - Scratch & Dent - Small / Cab Back Panel - Scratch - Small / Cargo Bed Floor - Scratch - Medium |
