## General Information

<b>Make</b>	Toyota	<b>Model</b>	Veloz
<b>YOM</b>	2023	<b>Odo Meter Reading</b>	21,048
<b>Registration No.</b>	GAK7882	<b>Chassis No.</b>	MHFAB1BY0P3051051
<b>CC</b>	1.5	<b>Transmission</b>	CVT
<b>Fuel Type</b>	Gas	<b>Type of Body</b>	SUV
<b>Colour</b>	Red Mica Metallic

## Body / Panel Condition

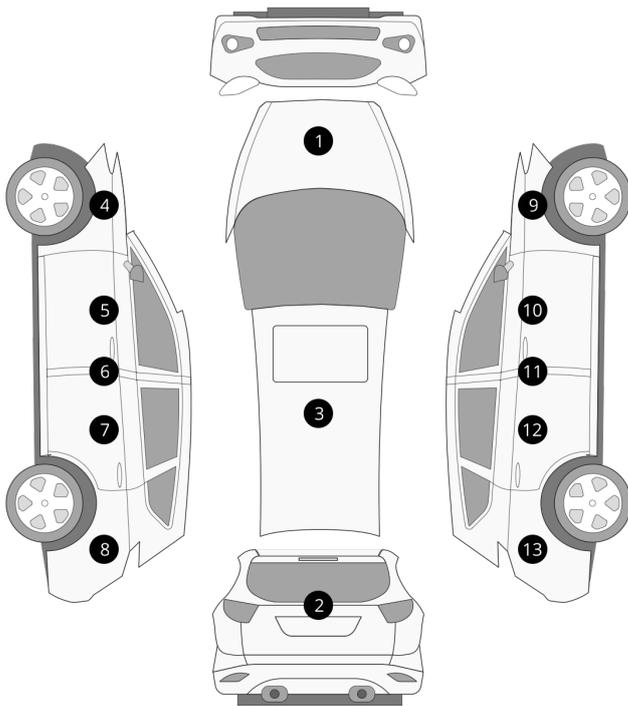
#	Area	Thickness(um)			
		Average	Value1	Value2	Value3/4
1	Bonnet	112.6	118	100	120
2	Boot Lid	108.1	102	125	97
3	Roof	110.0	120	112	100/108
4	Left Front Fender	105.3	105	104	107
5	Left Front Door	132.6	127	130	141
6	Center Panel Left				
7	Left Rear Door	132.0	112	141	143
8	Left Back Panel	122.6	131	123	114
9	Right Front Fender	99.2	100	100	98
10	Right Front Door	139.0	144	138	135
11	Center Panel Right				
12	Right Rear Door	135.6	125	128	154
13	Right Back Panel	119.3	109	122	127

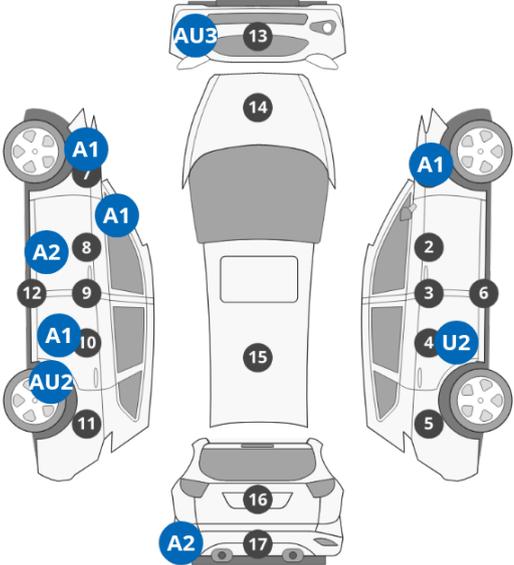
<p><b>A</b> : Scratch <b>AU</b> : Scratch &amp; Dent <b>B</b> : Modified <b>C</b> : Corrosion <b>G</b> : Stone chip <b>P</b> : Faded <b>S</b> : Rust <b>SC</b> : Rust &amp; Corrosion <b>U</b> : Dent <b>X</b> : Defective <b>Y</b> : Crack, Gap</p>
<p><b>Remarks</b> (R) Front Floor Mat - Grime - Small / Ceiling - Grime - Minimal / (L) Front Floor Mat - Grime - Small</p>	<p><b>Remarks</b> (L) Rear Fender, Molding - Scratch &amp; Dent - Small / (L) Front Fender, Molding - Scratch - Minimal / (L) Rear Door, Molding - Scratch - Minimal / (L) Front Door, Molding - Scratch - Small / (L) Mirror - Scratch - Minimal / (R) Rear Door, Molding - Dent - Small / (R) Front Fender, Molding - Scratch - Minimal / Rear Bumper, Lamps, Panels - Scratch - Small / Front Bumper, Grille, Lamps - Scratch &amp; Dent - Medium</p>
