## General Information

| Make | Toyota | Model | Vios |
| YOM | 2023 | Mileage | 23,767 |
| Registration No. | DBH5967 | Chassis No. | PA1B18F31P4207574 |

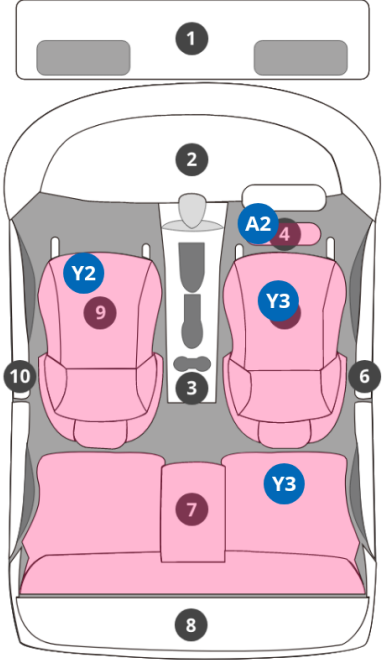
| Interior Evaluation : <b>B</b> | Exterior Evaluation : <b>C</b> |
| <b>Remarks</b><br>(L) Front Floor Mat - Cut, Crack - Small / (L) Front Seat - Grime - Small / Rear Seat - Grime - Medium / (R) Front Seat - Grime - Medium | <b>Remarks</b><br>(R) Rear Door, Molding - Scratch & Dent - Medium / (R) Rear Fender, Molding - Scratch & Dent - Small / (R) Step, In-panel, Side Spoiler - Scratch & Dent - Medium / (R) Rear Wheel, Cover - Cap Missing - Yes / Rear Bumper, Lamps, Panels - Scratch - Minimal / (L) Front Door, Molding - Scratch - Small / Front Bumper, Grille, Lamps - Scratch - Large / (R) Front Door, Molding - Scratch - Large / Trunk Hood, Rear Gate - Scratch & Dent - Minimal |
