## General Information

| Make | Toyota | Model | Vios |
| YOM | 2021 | Odo Meter Reading | 26,367 |
| Registration No. | NFI4979-1 | Chassis No. | PA1B18F37M4159476 |

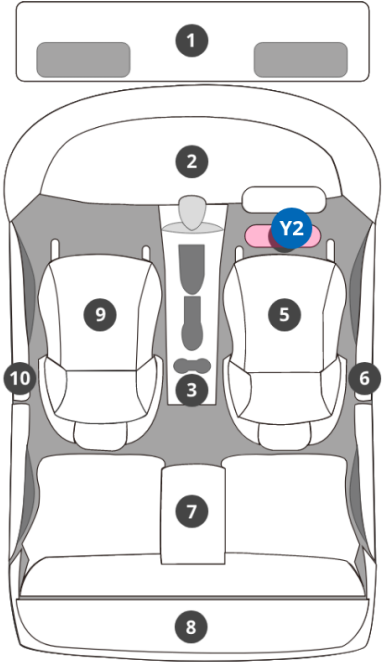
| Interior Evaluation : <span style="color: red;">A</span> | Exterior Evaluation : <span style="color: red;">E</span> |
|---|---|
| <b>Remarks</b><br>(L) Front Floor Mat - Grime - Small | <b>Remarks</b><br>(R) Rear Fender - Repair Traces - Yes / (R) Front Fender, Molding - Scratch - Medium / (R) Front Door, Molding - Scratch - Large / (R) Rear Door, Molding - Scratch - Large / (R) Rear Fender, Molding - Scratch & Dent - Large / Trunk Hood, Rear Gate - Scratch & Dent - Large / Rear Bumper, Lamps, Panels - Scratch & Dent - Large / (L) Rear Fender, Molding - Scratch & Dent - Large / (L) Rear Door, Molding - Scratch & Dent - Large / (L) Front Door, Molding - Scratch & Dent - Large / (L) Front Fender, Molding - Scratch - Large / Bonnet, Headlight - Scratch & Dent - Large / Front Bumper, Grille, Lamps - Scratch & Dent - Large |
