## General Information

| Make | Suzuki | Model | Ertiga |
| Registration No. | KAD7118 | Chassis No. | MHYNC22S6LJ108141 |

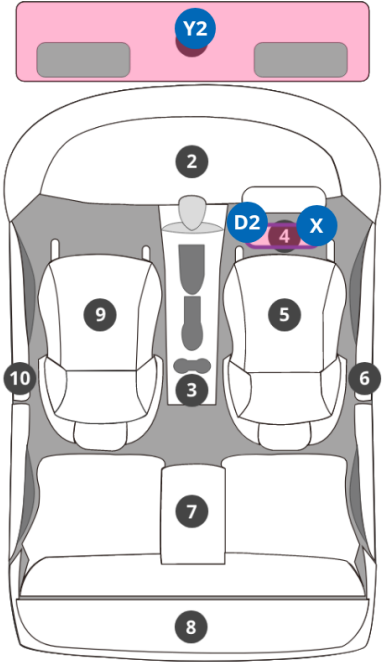
| Interior Evaluation : <b>B</b> | Exterior Evaluation : <b>D</b> |
| <b>Remarks</b><br>Ceiling - Grime - Small / (R) Front Floor Mat - Missing - Yes / (L) Front Floor Mat - Worked - Small | <b>Remarks</b><br>(R) Front Door - Repair Traces - Yes / (R) Front Fender - Repair Traces - Yes / Bonnet - Repair Traces - Yes / (L) Front Fender - Repair Traces - Yes / (L) Rear Door - Repair Traces - Yes / Trunk Hood, Rear Gate - Repair Traces - Yes / (R) Rear Fender - Repair Traces - Yes / (R) Rear Door - Repair Traces - Yes / Roof - Repair Traces - Yes / (L) Front Fender, Molding - Scratch & Dent - Large / (L) Front Door, Molding - Scratch - Large / (L) Rear Door, Molding - Scratch - Medium / (L) Rear Fender, Molding - Scratch - Small / Rear Bumper, Lamps, Panels - Scratch - Small / (R) Rear Door, Molding - Scratch - Small / (R) Mirror - Scratch - Small / (R) Front Fender, Molding - Scratch - Minimal / (R) Front Door, Molding - Scratch - Minimal / Front Bumper, Grille, Lamps - Scratch & Dent - Large / Roof - Scratch & Dent - Small |
