## General Information

<b>Make</b>	Toyota	<b>Model</b>	Avanza
<b>YOM</b>	2023	<b>Odo Meter Reading</b>	23,850
<b>Registration No.</b>	GAK9288	<b>Chassis No.</b>	MHFAB1BY6P3058408
<b>CC</b>	1.5	<b>Transmission</b>	CVT
<b>Fuel Type</b>	Gas	<b>Type of Body</b>	MPV
<b>Colour</b>	Green

## Body / Panel Condition

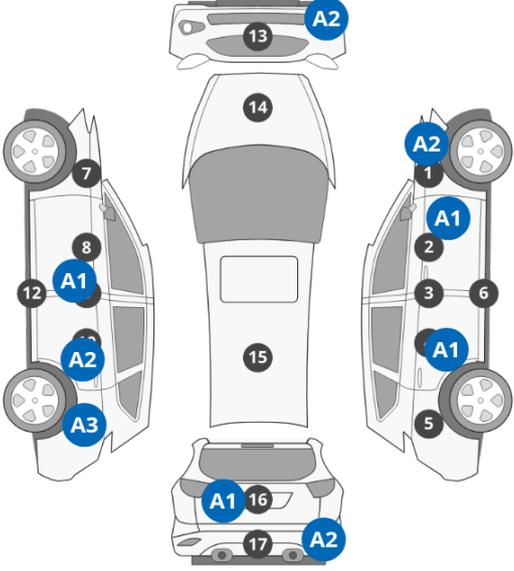
<p><b>A</b> : Scratch <b>AU</b> : Scratch &amp; Dent <b>B</b> : Modified <b>C</b> : Corrosion <b>G</b> : Stone chip <b>P</b> : Faded <b>S</b> : Rust <b>SC</b> : Rust &amp; Corrosion <b>U</b> : Dent <b>X</b> : Defective <b>Y</b> : Crack, Gap</p>
<p><b>Remarks</b> (R) Front Floor Mat - Grime - Small / Ceiling - Grime - Minimal / (L) Front Floor Mat - Grime - Minimal</p>	<p><b>Remarks</b> (L) Rear Door, Molding - Scratch - Small / (L) Front Door, Molding - Scratch - Minimal / (L) Rear Fender, Molding - Scratch - Medium / (R) Rear Door, Molding - Scratch - Minimal / Rear Bumper, Lamps, Panels - Scratch - Small / Front Bumper, Grille, Lamps - Scratch - Small / (R) Front Fender, Molding - Scratch - Small / (R) Front Door, Molding - Scratch - Minimal / Trunk Hood, Rear Gate - Scratch - Minimal</p>
