## General Information

Date & Time: 17, Nov, 2025 13:48

<b>Make</b>	Nissan	<b>Model</b>	Navara
<b>YOM</b>	2019	<b>Odo Meter Reading</b>	30,826
<b>Registration No.</b>	GAX2754	<b>Chassis No.</b>	MNTCC2D23Z0061706
<b>CC</b>	2.5	<b>Transmission</b>	A/T
<b>Fuel Type</b>	Diesel	<b>Type of Body</b>	Pickup
<b>Colour</b>	Silver

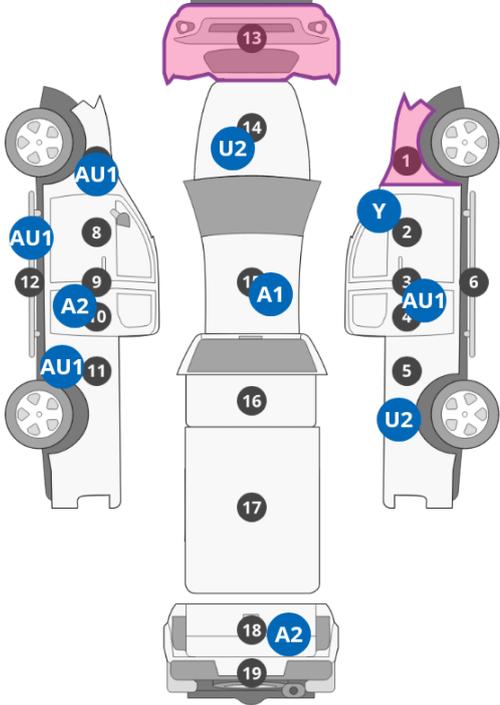
<p><b>A</b> : Scratch <b>AU</b> : Scratch &amp; Dent <b>B</b> : Modified <b>C</b> : Corrosion <b>G</b> : Stone chip <b>P</b> : Faded <b>S</b> : Rust <b>SC</b> : Rust &amp; Corrosion <b>U</b> : Dent <b>X</b> : Defective <b>Y</b> : Crack, Gap</p>
<p><b>Remarks</b> Ceiling - Grime - Small / (R) Front Trim - Grime - Minimal / (R) Rear Trim - Grime - Small / (L) Front Trim - Grime - Small</p>	<p><b>Remarks</b> (R) Front Fender - Repair Traces - Yes / (R) Front Fender, Molding - Repair mark - Yes / (R) Mirror - Crack - Cracks / (R) Rear Door, Molding - Scratch &amp; Dent - Minimal / (R) Side Gate - Dent - Small / (L) Side Gate - Scratch &amp; Dent - Minimal / Rear Gate - Scratch - Small / (L) Rear Door, Molding - Scratch - Small / (L) Step, In-panel, Side Spoiler - Scratch &amp; Dent - Minimal / Front Bumper, Grille, Lamps - Repair mark - Yes / (L) Front Fender, Molding - Scratch &amp; Dent - Minimal / Roof - Scratch - Minimal / Bonnet, Headlight - Dent - Small</p>
