General Information

Make	Toyota	Model	Vios
YOM	2023	Odo Meter Reading	36,063
Registration No.	DBJ6036	Chassis No.	PA1B18F33P4224604
CC	1.3	Transmission	CVT
Fuel Type	Gas	Type of Body	Sedan
Colour	Blue

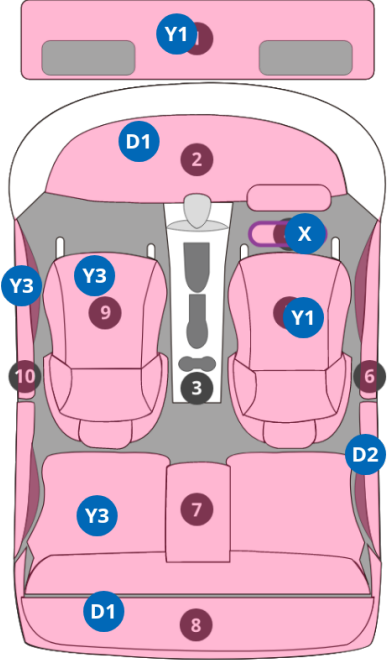
Interior Evaluation : B	Exterior Evaluation : D

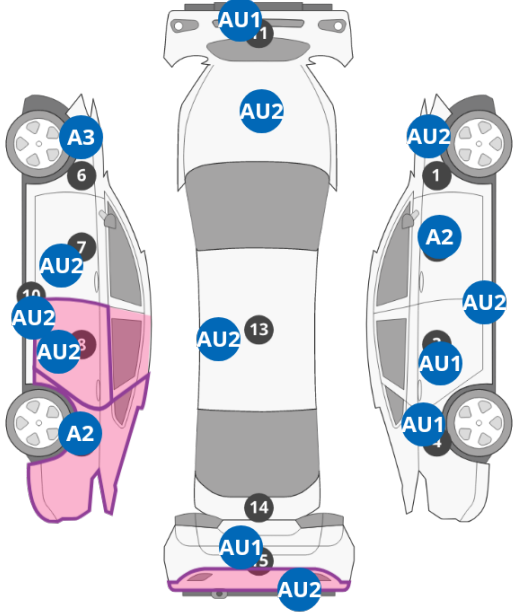
<p>A : Scratch AU : Scratch & Dent B : Modified C : Corrosion G : Stone chip P : Faded S : Rust SC : Rust & Corrosion U : Dent X : Defective Y : Crack, Gap</p>
<p>Remarks (L) Front Trim - Grime - Medium / (L) Front Seat - Grime - Medium / Rear Seat - Grime - Medium / (R) Rear Trim - Worked - Small / Trunk Room - Worked - Minimal / Dashboard - Worked - Minimal / Ceiling - Grime - Minimal / (R) Front Seat - Grime - Minimal / Mat Other - Missing - Yes</p>	<p>Remarks Bonnet - Repair Traces - Yes / (L) Front Door - Repair Traces - Yes / (L) Rear Door - Repair Traces - Yes / (L) Rear Fender - Repair Traces - Yes / Trunk Hood, Rear Gate - Repair Traces - Yes / Roof - Repair Traces - Yes / Rear Bumper, Lamps, Panels - Repair mark - Yes / (L) Rear Fender, Molding - Repair mark - Yes / (L) Rear Door, Molding - Repair mark - Yes / (L) Rear Fender, Molding - Scratch - Small / (L) Rear Door, Molding - Scratch & Dent - Small / (L) Step, In-panel, Side Spoiler - Scratch & Dent - Small / Roof - Scratch & Dent - Small / Trunk Hood, Rear Gate - Scratch & Dent - Minimal / (L) Front Door, Molding - Scratch & Dent - Small / (L) Front Fender, Molding - Scratch - Medium / Front Bumper, Grille, Lamps - Scratch & Dent - Minimal / Bonnet, Headlight - Scratch & Dent - Small / (R) Front Fender, Molding - Scratch & Dent - Small / (R) Front Door, Molding - Scratch - Small / (R) Step, In-panel, Side Spoiler - Scratch & Dent - Small / (R) Rear Door, Molding - Scratch & Dent - Minimal / (R) Rear Fender, Molding - Scratch & Dent - Minimal / Rear Bumper, Lamps, Panels - Scratch & Dent - Small</p>
