## General Information

| Make | Mitsubishi | Model | Mirage |
| Registration No. | CCC1290 | Chassis No. | PAEA13TJRPA015948 |

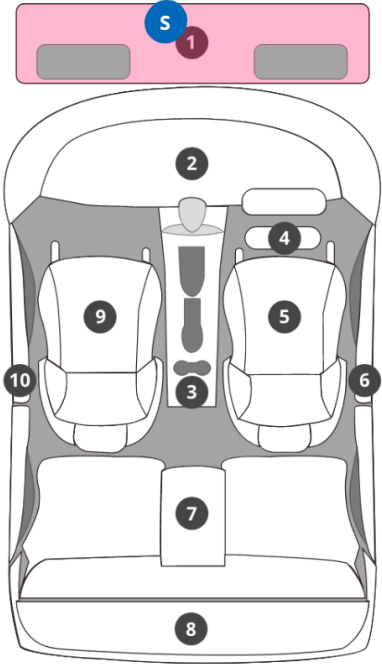
| Interior Evaluation : <b>B</b> | Exterior Evaluation : <b>D</b> |
| <b>Remarks</b><br>Ceiling - Grime - Small / Overall Interior - Smell - Yes | <b>Remarks</b><br>(R) Front Fender - Repair Traces - Yes / Bonnet - Repair Traces - Yes / (L) Front Fender - Repair Traces - Yes / Front Bumper, Grille, Lamps - Scratch - Small / (L) Front Fender, Molding - Repair mark - Yes / (R) Front Fender, Molding - Repair mark - Yes / Bonnet, Headlight - Repair mark - Yes / (L) Mirror - Scratch - Minimal / (L) Front Fender, Molding - Scratch - Small / (L) Front Door, Molding - Scratch - Minimal / (L) Rear Door, Molding - Scratch & Dent - Small / (L) Rear Fender, Molding - Scratch & Dent - Minimal / (L) Step, In-panel, Side Spoiler - Scratch & Dent - Minimal / Bonnet, Headlight - Scratch & Dent - Small / Roof - Scratch & Dent - Small / Member (Bolted) - Dent - Yes / (R) Mirror - Scratch - Minimal / (R) Front Fender, Molding - Scratch - Small / (R) Front Door, Molding - Scratch & Dent - Small / (R) Rear Door, Molding - Scratch - Minimal / (R) Step, In-panel, Side Spoiler - Scratch & Dent - Small / (R) Rear Fender, Molding - Scratch & Dent - Minimal / Trunk Hood, Rear Gate - Scratch & Dent - Small / Rear Bumper, Lamps, Panels - Scratch - Small |
