## General Information

<b>Make</b>	Suzuki	<b>Model</b>	Dzire
<b>YOM</b>	2025	<b>Odo Meter Reading</b>	7,694
<b>Registration No.</b>	NKO5584	<b>Chassis No.</b>	MBHZF63SXSG592842
<b>CC</b>	1.2	<b>Transmission</b>	A/T
<b>Fuel Type</b>	Gas	<b>Type of Body</b>	Sedan
<b>Colour</b>	Red

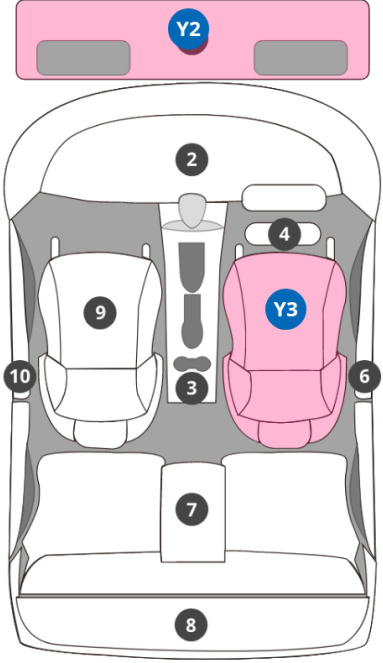
<b>Interior Evaluation :</b> <span style="float: right;"><b>B</b></span>	<b>Exterior Evaluation :</b> <span style="float: right;"><b>B</b></span>

<p><b>a</b> : Cut, Fray <b>d</b> : Loose, Deformed <b>k</b> : Animal Hair <b>s</b> : Smell <b>t</b> : Cigarette Burns <b>x</b> : Defective <b>y</b> : Stain</p>

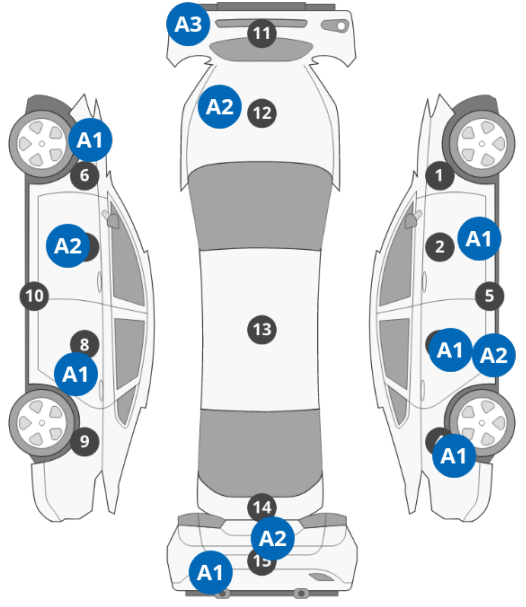
<p><b>A</b> : Scratch <b>AU</b> : Scratch &amp; Dent <b>B</b> : Modified <b>C</b> : Corrosion <b>G</b> : Stone chip <b>P</b> : Faded <b>S</b> : Rust <b>SC</b> : Rust &amp; Corrosion <b>U</b> : Dent <b>X</b> : Defective <b>Y</b> : Crack, Gap</p>
<b>Remarks</b> (R) Front Seat - Grime - Medium / Ceiling - Grime - Small	<b>Remarks</b> (L) Front Door, Molding - Scratch - Small / (L) Front Fender, Molding - Scratch - Minimal / (L) Rear Door, Molding - Scratch - Minimal / Trunk Hood, Rear Gate - Scratch - Small / Rear Bumper, Lamps, Panels - Scratch - Minimal / (R) Rear Fender, Molding - Scratch - Minimal / (R) Rear Door, Molding - Scratch - Minimal / (R) Step, In-panel, Side Spoiler - Scratch - Small / (R) Front Door, Molding - Scratch - Minimal / Front Bumper, Grille, Lamps - Scratch - Medium / Bonnet, Headlight - Scratch - Small
