## General Information

<b>Make</b>	Toyota	<b>Model</b>	Vios
<b>YOM</b>	2024	<b>Odo Meter Reading</b>	19,592
<b>Registration No.</b>	NFR5410	<b>Chassis No.</b>	PA1B18F32R4253255
<b>CC</b>	1.3	<b>Transmission</b>	CVT
<b>Fuel Type</b>	Gas	<b>Type of Body</b>	Sedan
<b>Colour</b>	Silver

## Body / Panel Condition

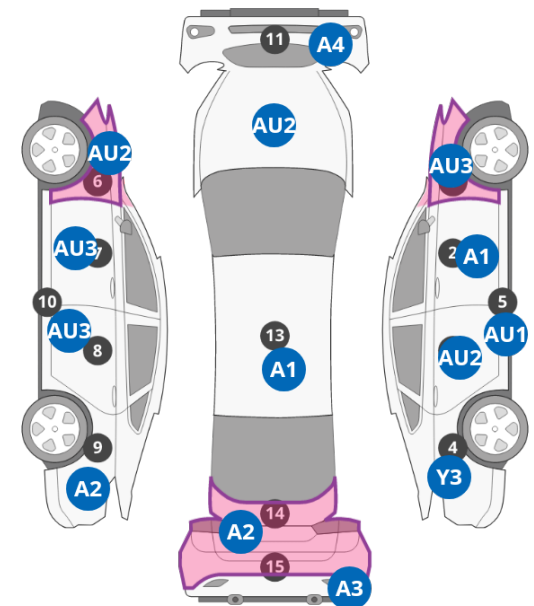
<p><b>A</b> : Scratch <b>AU</b> : Scratch &amp; Dent <b>B</b> : Modified <b>C</b> : Corrosion <b>G</b> : Stone chip <b>P</b> : Faded <b>S</b> : Rust <b>SC</b> : Rust &amp; Corrosion <b>U</b> : Dent <b>X</b> : Defective <b>Y</b> : Crack, Gap</p>
<p><b>Remarks</b> Rear Seat - Grime - Medium / (R) Front Seat - Grime - Small / (R) Front Trim - Grime - Minimal / (L) Front Seat - Grime - Medium / (L) Front Trim - Grime - Medium / Trunk Room - Worn, Scratch, Cut, Crack - Small / Ceiling - Grime - Minimal</p>	<p><b>Remarks</b> (R) Front Fender - Repair Traces - Yes / Trunk Hood, Rear Gate - Repair Traces - Yes / (R) Front Fender, Molding - Repair mark - Yes / Trunk Hood, Rear Gate - Repair mark - Yes / (L) Rear Door, Molding - Scratch &amp; Dent - Medium / (L) Front Door, Molding - Scratch &amp; Dent - Medium / (L) Front Fender, Molding - Scratch &amp; Dent - Small / (L) Front Fender, Molding - Repair mark - Yes / Front Bumper, Grille, Lamps - Scratch - Large / (R) Front Fender, Molding - Scratch &amp; Dent - Medium / Bonnet, Headlight - Scratch &amp; Dent - Small / (R) Step, In-panel, Side Spoiler - Scratch &amp; Dent - Minimal / (R) Front Door, Molding - Scratch - Minimal / (R) Rear Door, Molding - Scratch &amp; Dent - Small / (R) Rear Fender, Molding - Crack, Gap - Medium / Rear Bumper, Lamps, Panels - Scratch - Medium / (L) Rear Fender, Molding - Scratch - Small / Trunk Hood, Rear Gate - Scratch - Small / Roof - Scratch - Minimal</p>
