General Information

| Make | Toyota | Model | Vios |
| Registration No. | NHM1363 | Chassis No. | PA1B18F32P4236324 |

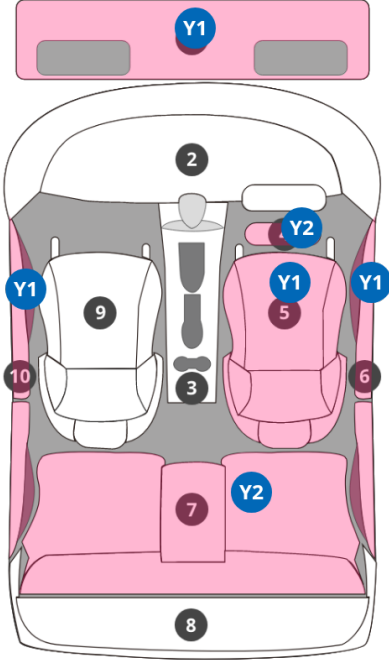
| Interior Evaluation : A | Exterior Evaluation : D |
| <p>Remarks (R) Front Seat - Grime - Minimal / (R) Front Trim - Grime - Minimal / Rear Seat - Grime - Small / (L) Front Trim - Grime - Minimal / (L) Front Floor Mat - Grime - Small / Ceiling - Grime - Minimal</p> | <p>Remarks (R) Front Door - Repair Traces - Yes / (L) Front Door, Molding - Scratch & Dent - Large / (R) Front Fender, Molding - Scratch - Medium / (R) Mirror - Scratch - Minimal / (R) Front Door, Molding - Scratch - Medium / (R) Rear Door, Molding - Scratch - Large / Trunk Hood, Rear Gate - Scratch & Dent - Medium / Rear Bumper, Lamps, Panels - Scratch - Large / (L) Rear Fender, Molding - Scratch - Minimal / Roof - Dent - Small / Front Bumper, Grille, Lamps - Scratch - Minimal / (L) Rear Door, Molding - Scratch - Minimal / (R) Rear Fender, Molding - Scratch - Minimal</p> |
