## General Information

<b>Make</b>	Toyota	<b>Model</b>	Vios
<b>YOM</b>	2025	<b>Odo Meter Reading</b>	37,246
<b>Registration No.</b>	DBQ2455	<b>Chassis No.</b>	PA1B18F36R4267210
<b>CC</b>	1.3	<b>Transmission</b>	CVT
<b>Fuel Type</b>	Gas	<b>Type of Body</b>	Sedan
<b>Colour</b>	Red Mica Metallic

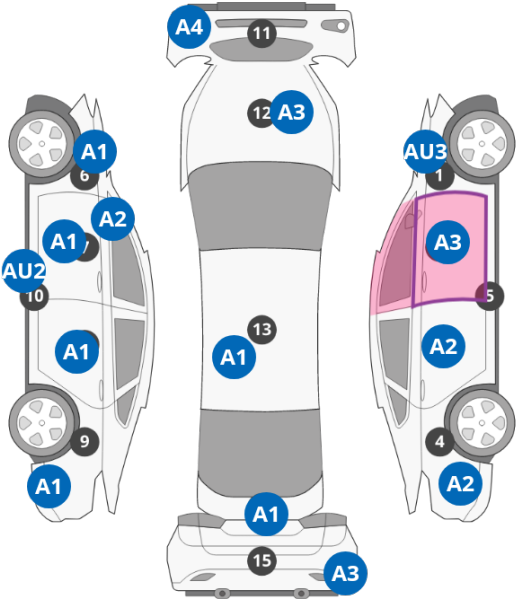
</div> <p><b>A</b> : Scratch <b>AU</b> : Scratch &amp; Dent <b>B</b> : Modified <b>C</b> : Corrosion <b>G</b> : Stone chip <b>P</b> : Faded <b>S</b> : Rust <b>SC</b> : Rust &amp; Corrosion <b>U</b> : Dent <b>X</b> : Defective <b>Y</b> : Crack, Gap</p>
<p><b>Remarks</b>  Rear Seat - Grime - Medium / (R) Rear Trim - Grime - Medium / (R) Front Trim - Grime - Medium / (R) Front Seat - Grime - Small / Trunk Room - Worn, Scratch, Cut, Crack - Small / (L) Rear Trim - Grime - Medium / (L) Front Trim - Grime - Medium / Steering Wheel - Worn, Peel, Crack - Medium / (L) Front Seat - Grime - Small / Dashboard - Traces of Adhesive Tape - Yes / Ceiling - Grime - Small / Console, Switches, Vents - Worn, Scratch, Cut, Crack - Small</p>	<p><b>Remarks</b>  (R) Front Door - Repair Traces - Yes / (L) Mirror - Scratch - Small / Bonnet, Headlight - Scratch - Medium / Front Bumper, Grille, Lamps - Scratch - Large / (R) Front Door, Molding - Repair mark - Yes / (R) Front Fender, Molding - Scratch &amp; Dent - Medium / (R) Front Door, Molding - Scratch - Medium / (R) Rear Door, Molding - Scratch - Small / Trunk Hood, Rear Gate - Scratch - Minimal / Rear Bumper, Lamps, Panels - Scratch - Medium / (L) Rear Fender, Molding - Scratch - Minimal / (L) Front Door, Molding - Scratch - Minimal / (L) Step, In-panel, Side Spoiler - Scratch &amp; Dent - Small / (R) Rear Fender, Molding - Scratch - Small / Roof - Scratch - Minimal / (L) Front Fender, Molding - Scratch - Minimal / (L) Rear Door, Molding - Scratch - Minimal</p>
