## General Information

| Make | MG | Model | HS |
| Registration No. | NEE8067 | Chassis No. | LSJA24UXNN099661 |

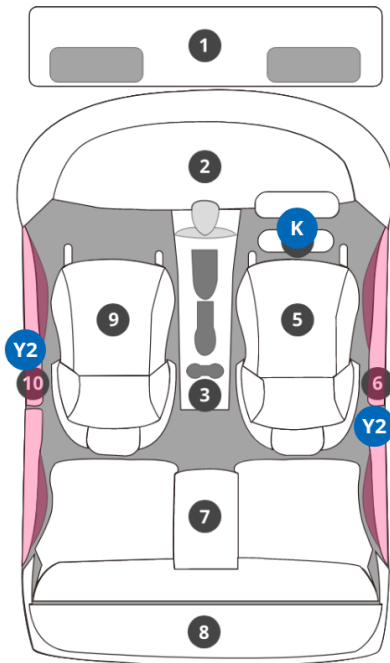
| Interior Evaluation : <b>B</b> | Exterior Evaluation : <b>D</b> |
|---|---|
| <p><b>Remarks</b></p> <p>Overall Interior - Animal Hair - Yes / (L) Rear Trim - Grime - Small / (R) Rear Trim - Grime - Small</p> | <p><b>Remarks</b></p> <p>Bonnet - Repair Traces - Yes / (L) Rear Fender - Repair Traces - Yes / (R) Rear Fender - Repair Traces - Yes / (R) Front Door, Molding - Scratch &amp; Dent - Medium / (R) Rear Door, Molding - Scratch &amp; Dent - Medium / (R) Rear Fender, Molding - Repair mark - Yes / Rear Bumper, Lamps, Panels - Scratch &amp; Dent - Medium / (L) Rear Fender, Molding - Repair mark - Yes / (L) Rear Door, Molding - Scratch &amp; Dent - Large / (L) Front Door, Molding - Scratch &amp; Dent - Minimal / (L) Mirror - Crack - Cracks / (L) Front Fender, Molding - Scratch - Minimal / Front Bumper, Grille, Lamps - Scratch &amp; Dent - Medium / Bonnet, Headlight - Scratch - Minimal</p> |
