## General Information

| Make | Toyota | Model | Hilux |
| Registration No. | EAE3942 | Chassis No. | MR0JB8DDXM3538026 |

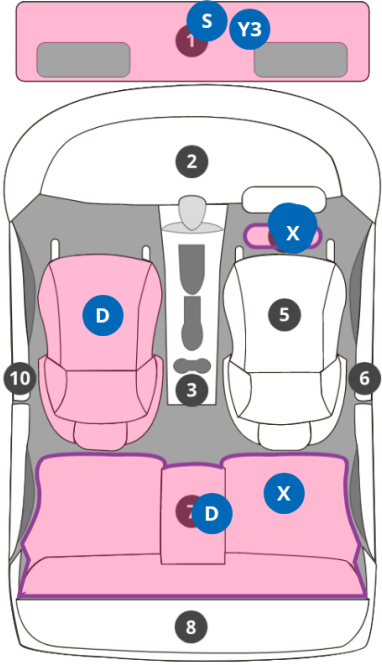
| Interior Evaluation : <span style="color: red;">C</span> | Exterior Evaluation : <span style="color: red;">E</span> |
| <p><b>Remarks</b></p> <p>Ceiling - Grime - Medium / Overall Interior - Smell - Yes / (L) Front Seat - Worn - Yes / (L) Front Floor Mat - Missing - Yes / (R) Front Floor Mat - Missing - Yes / Mat Other - Missing - Yes / Rear Seat - Worn - Yes / Rear Seat - Partially Missing - Yes</p> | <p><b>Remarks</b></p> <p>(R) Front Door - Repair Traces - Yes / (R) Front Fender - Repair Traces - Yes / Bonnet - Repair Traces - Yes / (L) Front Fender - Repair Traces - Yes / (L) Front Door - Repair Traces - Yes / Bonnet, Headlight - Repair mark - Yes / (R) Front Fender, Molding - Repair mark - Yes / (L) Front Fender, Molding - Repair mark - Yes / (L) Front Door, Molding - Repair mark - Yes / (L) Front Fender, Molding - Scratch - Small / Member (Bolted) - Dent - Yes / Front Bumper, Grille, Lamps - Scratch - Small / (R) Front Fender, Molding - Scratch &amp; Dent - Small / (R) Front Door, Molding - Scratch - Minimal / (R) Rear Door, Molding - Scratch - Minimal / (R) Step, In-panel, Side Spoiler - Scratch - Minimal / (R) Side Gate - Scratch &amp; Dent - Medium / Rear Bumper, Lamps, Panels - Scratch - Small / Rear Gate - Scratch - Small / Cargo Bed Floor - Crack, Gap - Medium / (L) Side Gate - Scratch &amp; Dent - Minimal / (L) Rear Door, Molding - Scratch &amp; Dent - Small / (L) Front Door, Molding - Dent - Small / (L) Mirror - Scratch - Minimal / (R) Mirror - Scratch - Minimal / Roof - Scratch &amp; Dent - Small / Cab Back Panel - Scratch - Small</p> |
