## General Information

<b>Make</b>	Toyota	<b>Model</b>	Vios
<b>YOM</b>	2023	<b>Odo Meter Reading</b>	40,781
<b>Registration No.</b>	FAO6060	<b>Chassis No.</b>	PA1B18F37P4212049
<b>CC</b>	1.3	<b>Transmission</b>	M/T
<b>Fuel Type</b>	Gas	<b>Type of Body</b>	Sedan
<b>Colour</b>	Blue

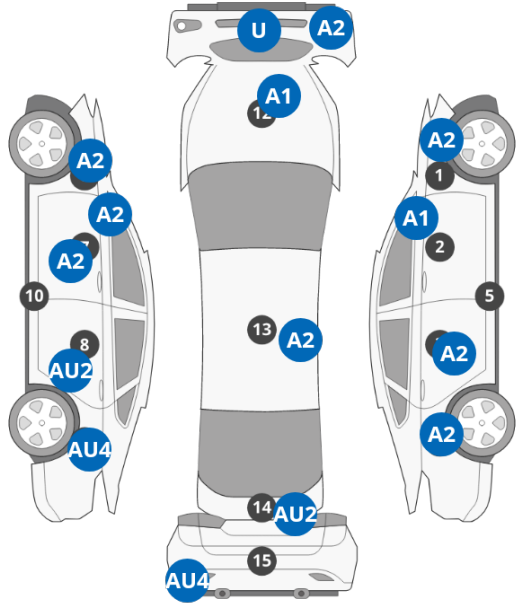
<p><b>A</b> : Scratch <b>AU</b> : Scratch &amp; Dent <b>B</b> : Modified <b>C</b> : Corrosion <b>G</b> : Stone chip <b>P</b> : Faded <b>S</b> : Rust <b>SC</b> : Rust &amp; Corrosion <b>U</b> : Dent <b>X</b> : Defective <b>Y</b> : Crack, Gap</p>
<p><b>Remarks</b> Ceiling - Grime - Small / (R) Front Trim - Grime - Small / (R) Front Floor Mat - Grime - Minimal / Mat Other - Grime - Minimal / (L) Front Trim - Grime - Small / (L) Front Floor Mat - Worked - Small</p>	<p><b>Remarks</b> (R) Front Fender, Molding - Scratch - Small / (R) Mirror - Scratch - Minimal / (R) Rear Door, Molding - Scratch - Small / (R) Rear Fender, Molding - Scratch - Small / Trunk Hood, Rear Gate - Scratch &amp; Dent - Small / Rear Bumper, Lamps, Panels - Scratch &amp; Dent - Large / (L) Rear Fender, Molding - Scratch &amp; Dent - Large / (L) Rear Door, Molding - Scratch &amp; Dent - Small / (L) Mirror - Scratch - Small / (L) Front Door, Molding - Scratch - Small / Roof - Scratch - Small / Bonnet, Headlight - Scratch - Minimal / Member (Bolted) - Dent - Yes / Front Bumper, Grille, Lamps - Scratch - Small / (L) Front Fender, Molding - Scratch - Small</p>

<p><b>Inspector Notes</b></p>
<p>Front bumper loose. Engine undercover loose. Gap at front bumper. Rust/corrosion at left rear fender. Without warranty booklet, jack and tools. With spare tire and seat cover. 1 key. With LTO plate.</p>
