General Information

| Make | Toyota | Model | Avanza |
| Registration No. | FAQ6905 | Chassis No. | MHFAA1BY7R0028616 |

Body / Panel Condition

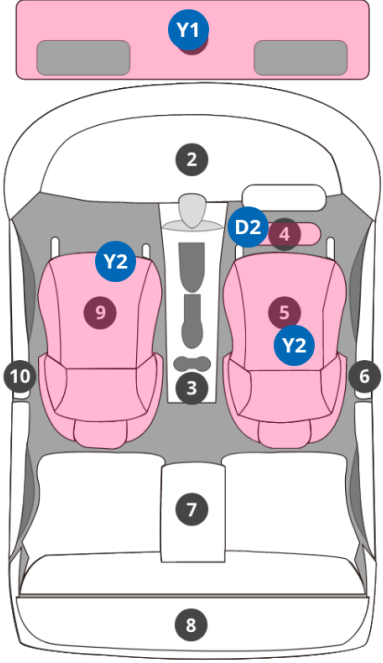
| <p>Remarks (R) Front Seat - Grime - Small / (L) Front Seat - Grime - Small / (L) Front Floor Mat - Worked - Small / Ceiling - Grime - Minimal</p> | <p>Remarks (L) Front Fender, Molding - Scratch & Dent - Large / (L) Front Door, Molding - Scratch & Dent - Large / (L) Step, In-panel, Side Spoiler - Scratch & Dent - Large / (L) Rear Door, Molding - Scratch & Dent - Large / (R) Mirror - Scratch - Minimal / Bonnet, Headlight - Scratch - Medium / (R) Rear Door, Molding - Scratch - Small / (R) Step, In-panel, Side Spoiler - Scratch - Small / (R) Front Door, Molding - Scratch - Small / (R) Rear Fender, Molding - Scratch - Minimal / Trunk Hood, Rear Gate - Scratch - Minimal / Rear Bumper, Lamps, Panels - Scratch - Small / Front Bumper, Grille, Lamps - Scratch & Dent - Medium</p> |

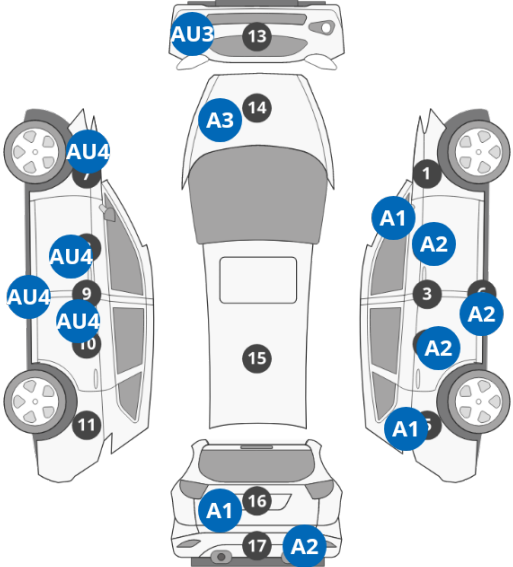
| <p>Damaged left front door, left front fender and left step in panel. Left side mirror damaged and unattached. With warranty booklet, and spare tire. Without tools and jack. 2 keys. With LTO plate.</p> |
