## General Information

Date & Time: 28, Nov, 2025 10:04

<b>Make</b>	Toyota	<b>Model</b>	Veloz
<b>YOM</b>	2025	<b>Odo Meter Reading</b>	9,162
<b>Registration No.</b>	GBJ8223	<b>Chassis No.</b>	MHFAB1BY3S3134773
<b>CC</b>	1.5	<b>Transmission</b>	CVT
<b>Fuel Type</b>	Gas	<b>Type of Body</b>	Wagon
<b>Colour</b>	Black

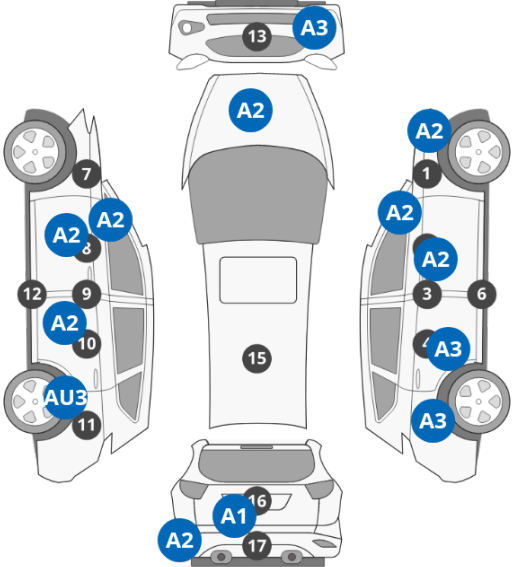
<p><b>A</b> : Scratch <b>AU</b> : Scratch &amp; Dent <b>B</b> : Modified <b>C</b> : Corrosion <b>G</b> : Stone chip <b>P</b> : Faded <b>S</b> : Rust <b>SC</b> : Rust &amp; Corrosion <b>U</b> : Dent <b>X</b> : Defective <b>Y</b> : Crack, Gap</p>
<p><b>Remarks</b> Ceiling - Grime - Small / (L) Front Floor Mat - Worked - Small / Mat Other - Grime - Small / Dashboard - Traces of Adhesive Tape - Yes</p>	<p><b>Remarks</b> (R) Front Fender, Molding - Scratch - Small / (R) Mirror - Scratch - Small / (R) Front Door, Molding - Scratch - Small / (R) Rear Door, Molding - Scratch - Medium / (R) Rear Fender, Molding - Scratch - Medium / Trunk Hood, Rear Gate - Scratch - Minimal / Rear Bumper, Lamps, Panels - Scratch - Small / (L) Rear Fender, Molding - Scratch &amp; Dent - Medium / (L) Rear Door, Molding - Scratch - Small / (L) Front Door, Molding - Scratch - Small / (L) Mirror - Scratch - Small / Bonnet, Headlight - Scratch - Small / Front Bumper, Grille, Lamps - Scratch - Medium</p>
