## General Information

Date & Time: 28, Nov, 2025 12:45

<b>Make</b>	Toyota	<b>Model</b>	Veloz
<b>YOM</b>	2024	<b>Odo Meter Reading</b>	1,991
<b>Registration No.</b>	GBJ9769	<b>Chassis No.</b>	MHFAB1BY5R3109125
<b>CC</b>	1.5	<b>Transmission</b>	CVT
<b>Fuel Type</b>	Gas	<b>Type of Body</b>	SUV
<b>Colour</b>	White

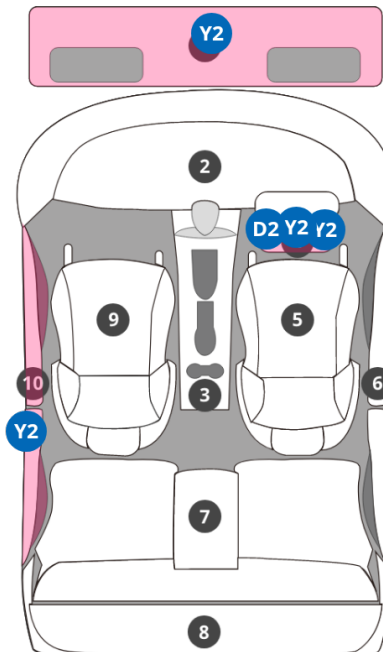
<b>Interior Evaluation :</b> <span style="float: right; color: red; font-weight: bold;">B</span>	<b>Exterior Evaluation :</b> <span style="float: right; color: red; font-weight: bold;">A</span>

<p><b>a</b> : Cut, Fray <b>d</b> : Loose, Deformed <b>k</b> : Animal Hair <b>s</b> : Smell <b>t</b> : Cigarette Burns <b>x</b> : Defective <b>y</b> : Stain</p>

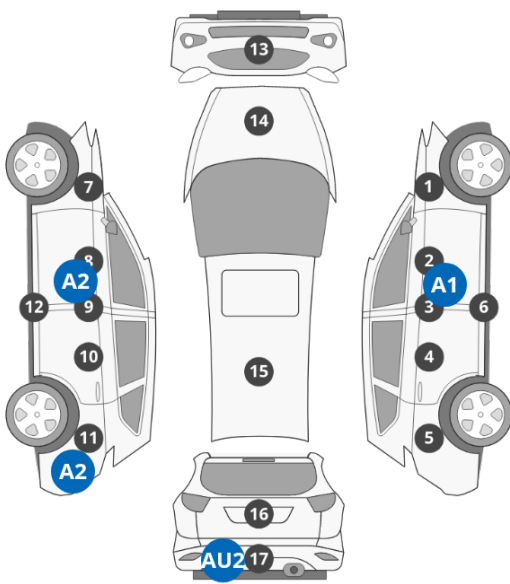
<p><b>A</b> : Scratch <b>AU</b> : Scratch &amp; Dent <b>B</b> : Modified <b>C</b> : Corrosion <b>G</b> : Stone chip <b>P</b> : Faded <b>S</b> : Rust <b>SC</b> : Rust &amp; Corrosion <b>U</b> : Dent <b>X</b> : Defective <b>Y</b> : Crack, Gap</p>
<p><b>Remarks</b> (R) Front Floor Mat - Grime - Small / Mat Other - Grime - Small / Ceiling - Grime - Small / (L) Rear Trim - Grime - Small / (L) Front Floor Mat - Worked - Small</p>	<p><b>Remarks</b> (R) Front Door - Repair Traces - Yes / (R) Step - Repair Traces - Yes / (R) Front Fender - Repair Traces - Yes / Trunk Hood, Rear Gate - Repair Traces - Yes / (R) Rear Fender - Repair Traces - Yes / (R) Rear Door - Repair Traces - Yes / (R) Front Door, Molding - Scratch - Minimal / Rear Bumper, Lamps, Panels - Scratch &amp; Dent - Small / (L) Rear Fender, Molding - Scratch - Small / (L) Front Door, Molding - Scratch - Small</p>
