## General Information

<b>Make</b>	Toyota	<b>Model</b>	Wigo
<b>YOM</b>	2025	<b>Odo Meter Reading</b>	8,833
<b>Registration No.</b>	GBJ4402	<b>Chassis No.</b>	MHKAA1BC4SJ035447
<b>CC</b>	1.0	<b>Transmission</b>	CVT
<b>Fuel Type</b>	Gas	<b>Type of Body</b>	Hatchback
<b>Colour</b>	Gray

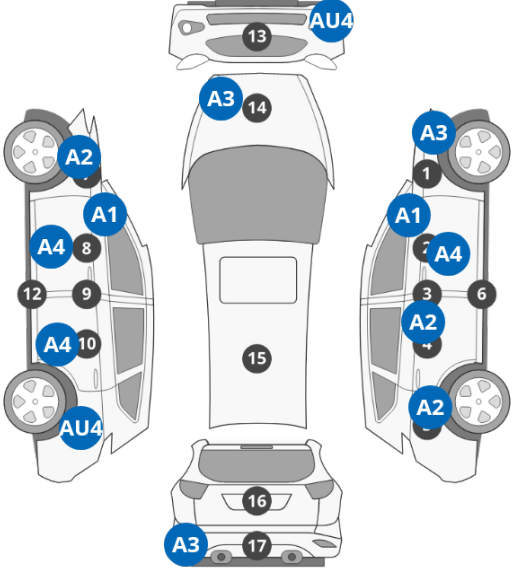
<p><b>A</b> : Scratch <b>AU</b> : Scratch &amp; Dent <b>B</b> : Modified <b>C</b> : Corrosion <b>G</b> : Stone chip <b>P</b> : Faded <b>S</b> : Rust <b>SC</b> : Rust &amp; Corrosion <b>U</b> : Dent <b>X</b> : Defective <b>Y</b> : Crack, Gap</p>
<p><b>Remarks</b> Ceiling - Grime - Minimal / (R) Front Floor Mat - Grime - Small / (L) Front Floor Mat - Worked - Small / Dashboard - Traces of Adhesive Tape - Yes</p>	<p><b>Remarks</b> (R) Mirror - Scratch - Minimal / (R) Front Door, Molding - Scratch - Large / (R) Front Fender, Molding - Scratch - Medium / (R) Rear Door, Molding - Scratch - Small / (R) Rear Fender, Molding - Scratch - Small / (L) Rear Fender, Molding - Scratch &amp; Dent - Large / (L) Rear Door, Molding - Scratch - Large / Rear Bumper, Lamps, Panels - Scratch - Medium / (L) Front Door, Molding - Scratch - Large / (L) Front Fender, Molding - Scratch - Small / (L) Mirror - Scratch - Minimal / Bonnet, Headlight - Scratch - Medium / Front Bumper, Grille, Lamps - Scratch &amp; Dent - Large</p>
