General Information

Make	Toyota	Model	Vios
YOM	2024	Odo Meter Reading	15,777
Registration No.	CCD3007	Chassis No.	PA1B18F39R4252846
CC	1.3	Transmission	CVT
Fuel Type	Gas	Type of Body	Sedan
Colour	Blackish Red Mica

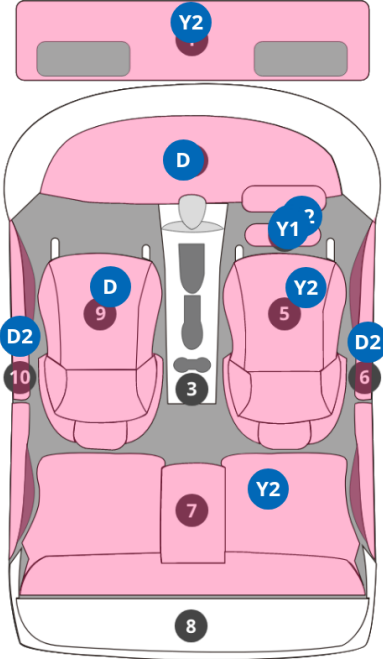
Interior Evaluation : A	Exterior Evaluation : E

<p>a : Cut, Fray d : Loose, Deformed k : Animal Hair s : Smell t : Cigarette Burns x : Defective y : Stain</p>

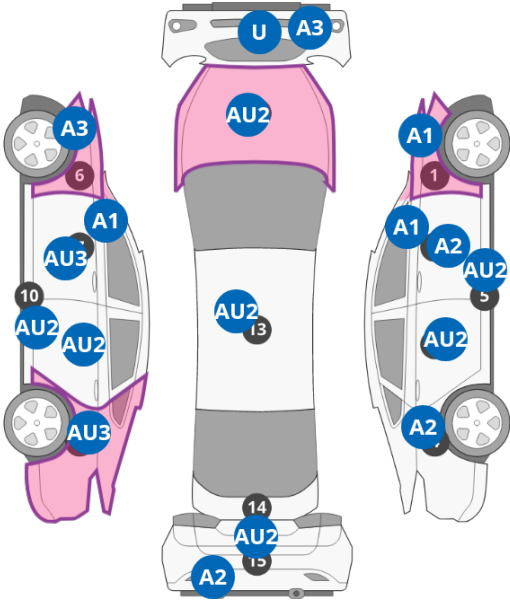
<p>A : Scratch AU : Scratch & Dent B : Modified C : Corrosion G : Stone chip P : Faded S : Rust SC : Rust & Corrosion U : Dent X : Defective Y : Crack, Gap</p>
<p>Remarks (R) Front Seat - Grime - Small / (L) Front Trim - Worked - Small / (R) Front Trim - Worked - Small</p>	<p>Remarks (R) Front Fender - Repair Traces - Yes / Bonnet - Repair Traces - Yes / (L) Front Fender - Repair Traces - Yes / (L) Rear Fender - Repair Traces - Yes / Trunk Hood, Rear Gate - Repair Traces - Yes / (L) Rear Fender, Molding - Repair mark - Yes / (L) Front Fender, Molding - Repair mark - Yes / Bonnet, Headlight - Repair mark - Yes / (R) Front Fender, Molding - Repair mark - Yes / Member (Bolted) - Dent - Yes / (L) Front Fender, Molding - Scratch - Medium / Front Bumper, Grille, Lamps - Scratch - Medium / (R) Front Fender, Molding - Scratch - Minimal / (R) Front Door, Molding - Scratch - Small / (R) Rear Door, Molding - Scratch & Dent - Small / (R) Step, In-panel, Side Spoiler - Scratch & Dent - Small / (R) Mirror - Scratch - Minimal / (R) Rear Fender, Molding - Scratch - Small / Trunk Hood, Rear Gate - Scratch & Dent - Small / Rear Bumper, Lamps, Panels - Scratch - Small / (L) Rear Fender, Molding - Scratch & Dent - Medium / (L) Rear Door, Molding - Scratch & Dent - Small / (L) Front Door, Molding - Scratch & Dent - Medium / (L) Step, In-panel, Side Spoiler - Scratch & Dent - Small / (L) Mirror - Scratch - Minimal / Roof - Scratch & Dent - Small / Bonnet, Headlight - Scratch & Dent - Small</p>
