## General Information

<b>Make</b>	Toyota	<b>Model</b>	Vios
<b>YOM</b>	2025	<b>Odo Meter Reading</b>	4,770
<b>Registration No.</b>	CCG8836	<b>Chassis No.</b>	PA1B18F37S4286550
<b>CC</b>	1.3	<b>Transmission</b>	CVT
<b>Fuel Type</b>	Gas	<b>Type of Body</b>	Sedan
<b>Colour</b>	Blue

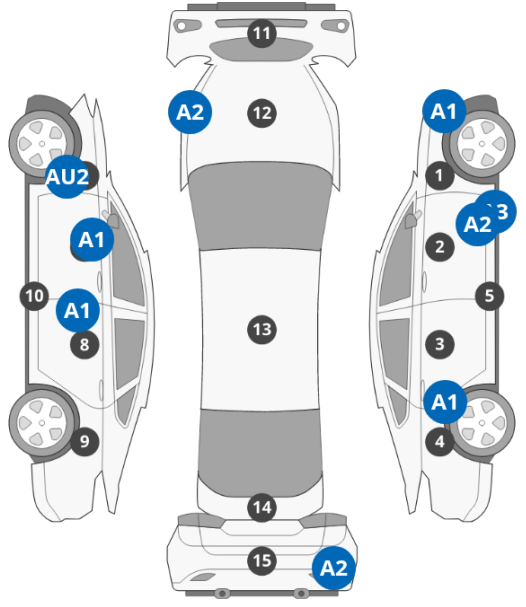
<p><b>A</b> : Scratch <b>AU</b> : Scratch &amp; Dent <b>B</b> : Modified <b>C</b> : Corrosion <b>G</b> : Stone chip <b>P</b> : Faded <b>S</b> : Rust <b>SC</b> : Rust &amp; Corrosion <b>U</b> : Dent <b>X</b> : Defective <b>Y</b> : Crack, Gap</p>
<p><b>Remarks</b> (R) Front Floor Mat - Missing - Yes / (L) Front Floor Mat - Missing - Yes / Mat Other - Missing - Yes</p>	<p><b>Remarks</b> (R) Front Fender, Molding - Scratch - Minimal / (R) Rear Fender, Molding - Scratch - Minimal / Rear Bumper, Lamps, Panels - Scratch - Small / (L) Front Fender, Molding - Scratch &amp; Dent - Small / (L) Front Door, Molding - Scratch - Minimal / (L) Rear Door, Molding - Scratch - Minimal / Bonnet, Headlight - Scratch - Small / (R) Step, In-panel, Side Spoiler - Scratch - Medium / (R) Front Door, Molding - Scratch - Small</p>
