## General Information

<b>Make</b>	Toyota	<b>Model</b>	Wigo
<b>YOM</b>	2025	<b>Odo Meter Reading</b>	6,652
<b>Registration No.</b>	GBK1866	<b>Chassis No.</b>	MHKAA1BC9SJ037825
<b>CC</b>	1.0	<b>Transmission</b>	CVT
<b>Fuel Type</b>	Gas	<b>Type of Body</b>	Hatchback
<b>Colour</b>	Red

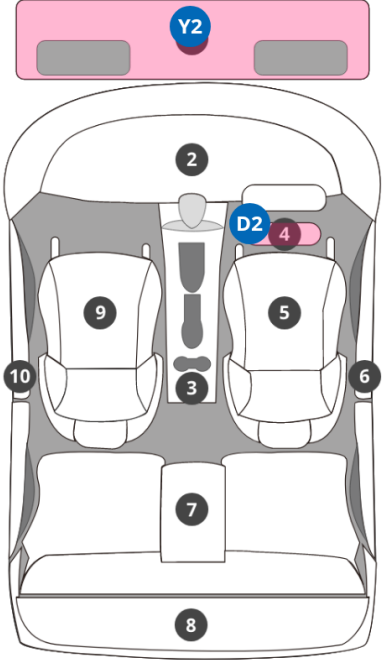
<b>Interior Evaluation :</b> <span style="float: right; color: red; font-weight: bold;">A</span>	<b>Exterior Evaluation :</b> <span style="float: right; color: red; font-weight: bold;">C</span>

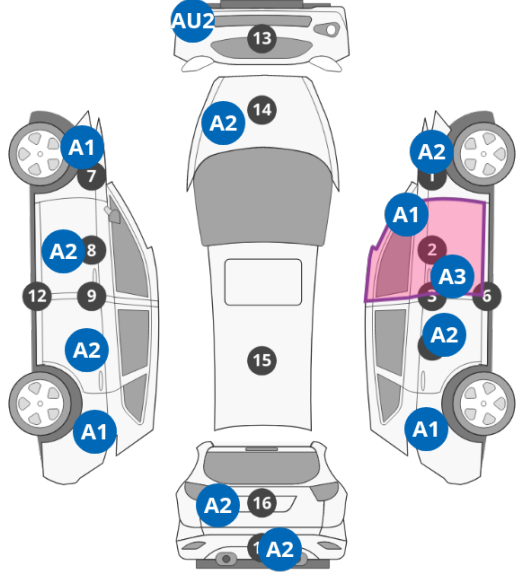
<p><b>A</b> : Scratch <b>AU</b> : Scratch &amp; Dent <b>B</b> : Modified <b>C</b> : Corrosion <b>G</b> : Stone chip <b>P</b> : Faded <b>S</b> : Rust <b>SC</b> : Rust &amp; Corrosion <b>U</b> : Dent <b>X</b> : Defective <b>Y</b> : Crack, Gap</p>
<p><b>Remarks</b> Ceiling - Grime - Small / (L) Front Floor Mat - Worked - Small</p>	<p><b>Remarks</b> (R) Rear Door - Repair Traces - Yes / (R) Front Fender, Molding - Scratch - Small / (R) Front Door, Molding - Scratch - Medium / (R) Mirror - Scratch - Minimal / (R) Front Door, Molding - Repair mark - Yes / (R) Rear Door, Molding - Scratch - Small / (R) Rear Fender, Molding - Scratch - Minimal / Rear Bumper, Lamps, Panels - Scratch - Small / Trunk Hood, Rear Gate - Scratch - Small / (L) Rear Door, Molding - Scratch - Small / (L) Rear Fender, Molding - Scratch - Minimal / (L) Front Door, Molding - Scratch - Small / (L) Front Fender, Molding - Scratch - Minimal / Bonnet, Headlight - Scratch - Small / Front Bumper, Grille, Lamps - Scratch &amp; Dent - Small</p>
