## General Information

Date & Time: 05, Jan, 2026 13:05

<b>Make</b>	Toyota	<b>Model</b>	Vios
<b>YOM</b>	2024	<b>Odo Meter Reading</b>	9,832
<b>Registration No.</b>	GBE5939	<b>Chassis No.</b>	PA1B18F33R4259453
<b>CC</b>	1.3	<b>Transmission</b>	CVT
<b>Fuel Type</b>	Gas	<b>Type of Body</b>	Sedan
<b>Colour</b>	Silver

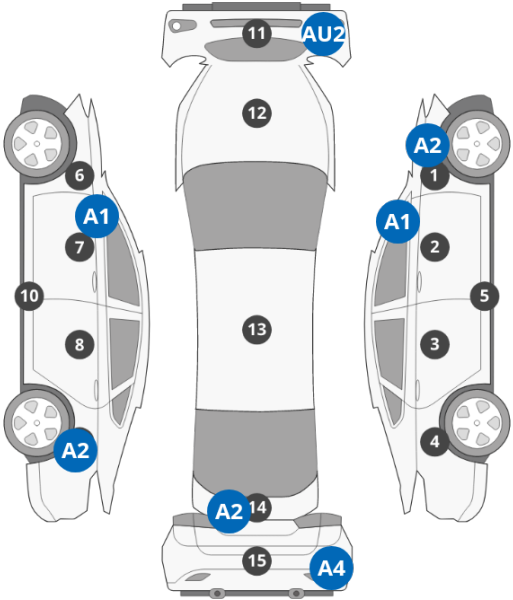
<p><b>A</b> : Scratch <b>AU</b> : Scratch &amp; Dent <b>B</b> : Modified <b>C</b> : Corrosion <b>G</b> : Stone chip <b>P</b> : Faded <b>S</b> : Rust <b>SC</b> : Rust &amp; Corrosion <b>U</b> : Dent <b>X</b> : Defective <b>Y</b> : Crack, Gap</p>
<p><b>Remarks</b> Ceiling - Grime - Small / (R) Front Trim - Grime - Small / (R) Front Floor Mat - Grime - Medium / Mat Other - Grime - Small / (L) Front Trim - Grime - Small / (L) Front Floor Mat - Worked - Small</p>	<p><b>Remarks</b> Bonnet - Repair Traces - Yes / (L) Mirror - Scratch - Minimal / (L) Rear Fender, Molding - Scratch - Small / Rear Bumper, Lamps, Panels - Scratch - Large / Trunk Hood, Rear Gate - Scratch - Small / (R) Mirror - Scratch - Minimal / (R) Front Fender, Molding - Scratch - Small / Front Bumper, Grille, Lamps - Scratch &amp; Dent - Small</p>
