## General Information

<b>Make</b>	Suzuki	<b>Model</b>	Carry
<b>YOM</b>	2023	<b>Odo Meter Reading</b>	16,239
<b>Registration No.</b>	NHF6693	<b>Chassis No.</b>	MHYDC61T1PJ214824
<b>CC</b>	1.5	<b>Transmission</b>	M/T
<b>Fuel Type</b>	Diesel	<b>Type of Body</b>	Dropside
<b>Colour</b>	White

## Body / Panel Condition

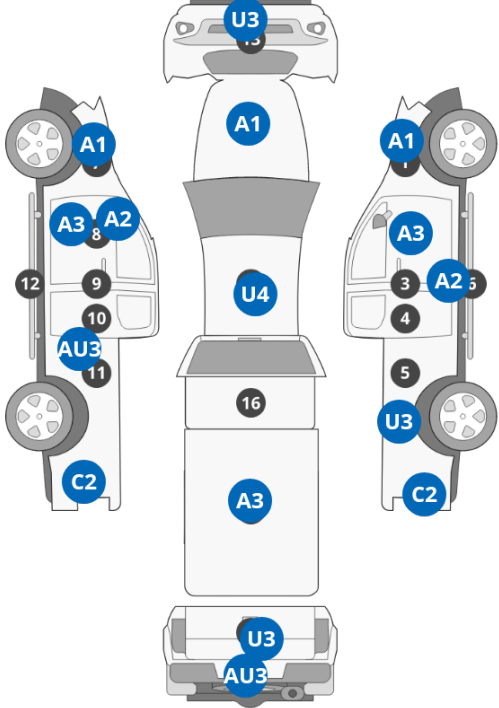
<p><b>A</b> : Scratch <b>AU</b> : Scratch &amp; Dent <b>B</b> : Modified <b>C</b> : Corrosion <b>G</b> : Stone chip <b>P</b> : Faded <b>S</b> : Rust <b>SC</b> : Rust &amp; Corrosion <b>U</b> : Dent <b>X</b> : Defective <b>Y</b> : Crack, Gap</p>
<p><b>Remarks</b> (R) Front Seat - Grime - Large / (R) Front Trim - Grime - Large / (L) Front Trim - Grime - Large / (L) Front Seat - Grime - Small / (R) Front Floor Mat - Missing - Yes / (L) Front Floor Mat - Missing - Yes / Ceiling - Grime - Large / Dashboard - Worn, Scratch, Cut, Crack - Small / Console, Switchs, Vents - Worn, Scratch, Cut, Crack - Small</p>	<p><b>Remarks</b> (L) Side Gate - Scratch &amp; Dent - Medium / (L) Front Door, Molding - Scratch - Medium / (L) Mirror - Scratch - Small / Front Bumper, Grille, Lamps - Dent - Medium / (L) Front Fender, Molding - Scratch - Minimal / (R) Front Fender, Molding - Scratch - Minimal / (R) Front Door, Molding - Scratch - Medium / (R) Center Panel - Scratch - Small / (R) Side Gate - Dent - Medium / (R) Rear Wheel, Cover - Scratch, Corrosion - Small / Rear Gate - Dent - Medium / Rear Bumper, Lamps, Panels - Scratch &amp; Dent - Medium / (L) Rear Wheel, Cover - Scratch, Corrosion - Small / Cargo Bed Floor - Scratch - Medium / Roof - Dent - Large / Bonnet, Headlight - Scratch - Minimal</p>
