## General Information

<b>Make</b>	Mitsubishi	<b>Model</b>	Mirage
<b>YOM</b>	2023	<b>Odo Meter Reading</b>	53,372
<b>Registration No.</b>	NIL5121	<b>Chassis No.</b>	PAEA13TJPPA006373
<b>CC</b>	1.2	<b>Transmission</b>	A/T
<b>Fuel Type</b>	Gas	<b>Type of Body</b>	Sedan
<b>Colour</b>	Gray

## Body / Panel Condition

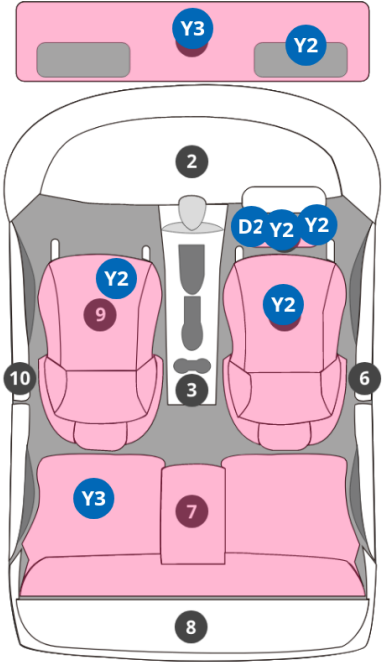
<b>Interior Evaluation :</b> <span style="float: right; color: red; font-weight: bold;">C</span>	<b>Exterior Evaluation :</b> <span style="float: right; color: red; font-weight: bold;">D</span>

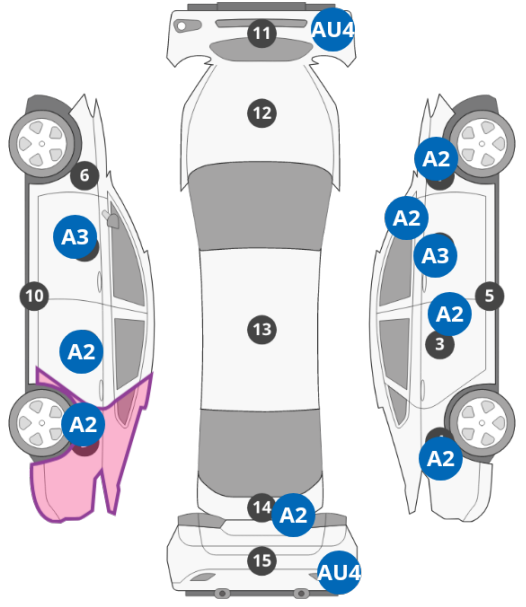
<p><b>A :</b> Scratch <b>AU :</b> Scratch &amp; Dent <b>B :</b> Modified <b>C :</b> Corrosion <b>G :</b> Stone chip <b>P :</b> Faded <b>S :</b> Rust <b>SC :</b> Rust &amp; Corrosion <b>U :</b> Dent <b>X :</b> Defective <b>Y :</b> Crack, Gap</p>
<p><b>Remarks</b> Ceiling - Grime - Medium / Sunvisor, Sunglass Holder - Grime - Small / Rear Seat - Grime - Medium / (L) Front Seat - Grime - Small / (R) Front Seat - Grime - Small / (L) Front Floor Mat - Worked - Small / (R) Front Floor Mat - Grime - Small / Mat Other - Grime - Small</p>	<p><b>Remarks</b> (L) Rear Fender - Repair Traces - Yes / (R) Rear Fender - Repair Traces - Yes / (R) Front Door, Molding - Scratch - Medium / (R) Mirror - Scratch - Small / (R) Front Fender, Molding - Scratch - Small / (R) Rear Door, Molding - Scratch - Small / (R) Rear Fender, Molding - Scratch - Small / Rear Bumper, Lamps, Panels - Scratch &amp; Dent - Large / Trunk Hood, Rear Gate - Scratch - Small / (L) Rear Fender, Molding - Scratch - Small / (L) Rear Door, Molding - Scratch - Small / (L) Front Door, Molding - Scratch - Medium / Front Bumper, Grille, Lamps - Scratch &amp; Dent - Large / (L) Rear Wheel, Cover - Cap Missing - Yes</p>
