## General Information

<b>Make</b>	Toyota	<b>Model</b>	Vios
<b>YOM</b>	2025	<b>Odo Meter Reading</b>	7,654
<b>Registration No.</b>	NJF1303	<b>Chassis No.</b>	PA1B18F3XR4279926
<b>CC</b>	1.3	<b>Transmission</b>	CVT
<b>Fuel Type</b>	Gas	<b>Type of Body</b>	Sedan
<b>Colour</b>	Red Mica Metallic

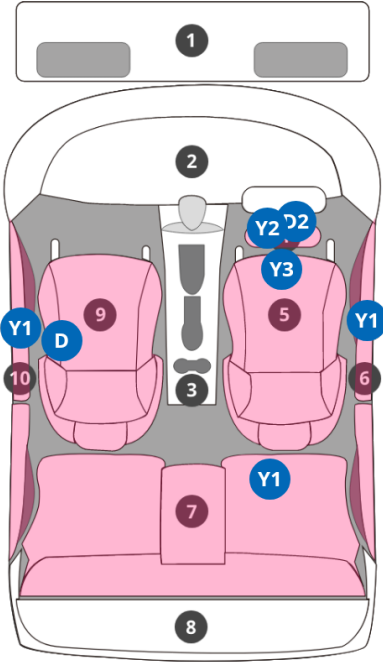
<b>Interior Evaluation :</b> <span style="float: right; color: red; font-weight: bold;">B</span>	<b>Exterior Evaluation :</b> <span style="float: right; color: red; font-weight: bold;">E</span>

<p><b>A</b> : Scratch <b>AU</b> : Scratch &amp; Dent <b>B</b> : Modified <b>C</b> : Corrosion <b>G</b> : Stone chip <b>P</b> : Faded <b>S</b> : Rust <b>SC</b> : Rust &amp; Corrosion <b>U</b> : Dent <b>X</b> : Defective <b>Y</b> : Crack, Gap</p>
<p><b>Remarks</b> (R) Front Seat - Grime - Medium / (L) Front Floor Mat - Worked - Small / (L) Front Seat - Worn - Yes / (R) Front Trim - Grime - Minimal / (L) Front Trim - Grime - Minimal / Rear Seat - Grime - Minimal / (R) Front Floor Mat - Grime - Small</p>	<p><b>Remarks</b> (R) Front Fender, Molding - Repair mark - Yes / (R) Front Fender, Molding - Scratch &amp; Dent - Large / (R) Mirror - Scratch - Small / (R) Rear Door, Molding - Scratch - Small / (R) Front Door, Molding - Scratch - Medium / Rear Bumper, Lamps, Panels - Repair mark - Yes / (R) Rear Fender, Molding - Scratch - Small / Rear Bumper, Lamps, Panels - Scratch &amp; Dent - Large / Trunk Hood, Rear Gate - Scratch &amp; Dent - Medium / (L) Rear Fender, Molding - Scratch - Small / (L) Front Door, Molding - Scratch - Small / (L) Rear Door, Molding - Scratch - Medium / (L) Mirror - Scratch - Minimal / (L) Front Fender, Molding - Scratch - Small / Front Bumper, Grille, Lamps - Repair mark - Yes / Front Bumper, Grille, Lamps - Scratch - Large / Bonnet, Headlight - Scratch - Small / Roof - Scratch - Minimal</p>

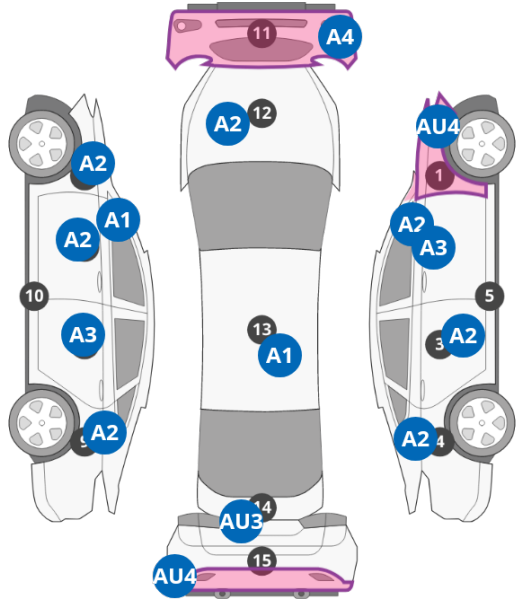
<p><b>Inspector Notes</b></p>
<p>with warranty booklet, no jack and tools, with spare tire and LTO PLATE, scratched and cracked tail light</p>
