General Information

Make	Toyota	Model	Vios
YOM	2023	Odo Meter Reading	94,067
Registration No.	NHJ2651	Chassis No.	PA1B18F39P4215616
CC	1.3	Transmission	CVT
Fuel Type	Gas	Type of Body	Sedan
Colour	Black

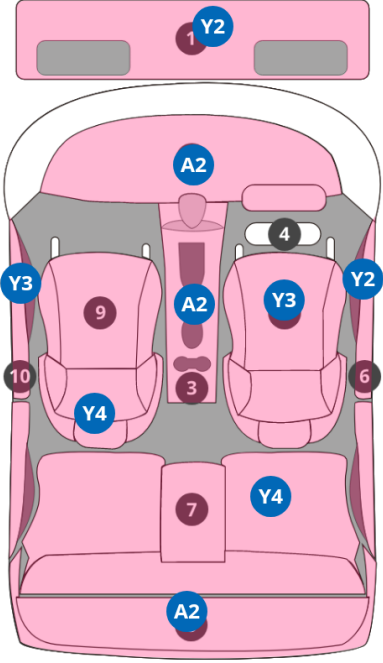
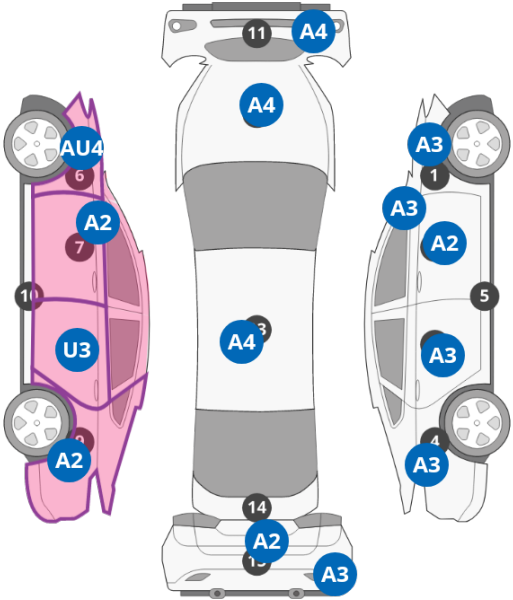
Interior Evaluation :	C	Exterior Evaluation :	E

<p>a : Cut, Fray d : Loose, Deformed k : Animal Hair s : Smell t : Cigarette Burns x : Defective y : Stain</p>		<p>A : Scratch AU : Scratch & Dent B : Modified C : Corrosion G : Stone chip P : Faded S : Rust SC : Rust & Corrosion U : Dent X : Defective Y : Crack, Gap</p>	
<p>Remarks Trunk Room - Worn, Scratch, Cut, Crack - Small / Rear Seat - Grime - Large / (R) Front Trim - Grime - Small / (R) Front Seat - Grime - Medium / (L) Front Seat - Grime - Large / (L) Front Trim - Grime - Medium / Console, Switches, Vents - Worn, Scratch, Cut, Crack - Small / Dashboard - Worn, Scratch, Cut, Crack - Small / Ceiling - Grime - Small</p>		<p>Remarks (R) Front Door - Repair Traces - Yes / (R) Front Fender - Repair Traces - Yes / Bonnet - Repair Traces - Yes / (L) Front Fender - Repair Traces - Yes / (L) Rear Door - Repair Traces - Yes / (L) Rear Fender - Repair Traces - Yes / Trunk Hood, Rear Gate - Repair Traces - Yes / (R) Rear Fender - Repair Traces - Yes / (R) Rear Door - Repair Traces - Yes / Roof - Repair Traces - Yes / Roof - Scratch - Large / (L) Rear Fender, Molding - Repair mark - Yes / (L) Rear Door, Molding - Repair mark - Yes / (L) Front Door, Molding - Repair mark - Yes / (L) Front Fender, Molding - Repair mark - Yes / (L) Front Fender, Molding - Scratch & Dent - Large / (L) Mirror - Scratch - Small / (L) Rear Door, Molding - Dent - Medium / (L) Rear Fender, Molding - Scratch - Small / Trunk Hood, Rear Gate - Scratch - Small / Rear Bumper, Lamps, Panels - Scratch - Medium / (R) Rear Fender, Molding - Scratch - Medium / (R) Rear Door, Molding - Scratch - Medium / (R) Front Door, Molding - Scratch - Small / (R) Mirror - Scratch - Medium / (R) Front Fender, Molding - Scratch - Medium / Bonnet, Headlight - Scratch - Large / Front Bumper, Grille, Lamps - Scratch - Large</p>
