## General Information

Date & Time: 26, Nov, 2025 12:34

<b>Make</b>	Toyota	<b>Model</b>	Vios
<b>YOM</b>	2023	<b>Odo Meter Reading</b>	27,140
<b>Registration No.</b>	NIR2988	<b>Chassis No.</b>	PA1B18F37P4220670
<b>CC</b>	1.3	<b>Transmission</b>	CVT
<b>Fuel Type</b>	Gas	<b>Type of Body</b>	Sedan
<b>Colour</b>	Red

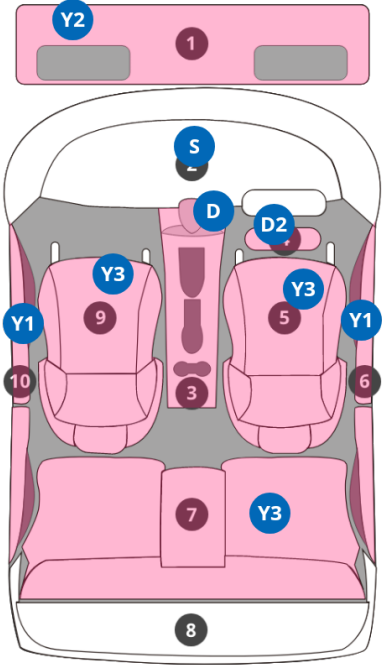
<b>Interior Evaluation :</b> <span style="float: right; color: red; font-weight: bold;">C</span>	<b>Exterior Evaluation :</b> <span style="float: right; color: red; font-weight: bold;">E</span>

<p><b>A</b> : Scratch <b>AU</b> : Scratch &amp; Dent <b>B</b> : Modified <b>C</b> : Corrosion <b>G</b> : Stone chip <b>P</b> : Faded <b>S</b> : Rust <b>SC</b> : Rust &amp; Corrosion <b>U</b> : Dent <b>X</b> : Defective <b>Y</b> : Crack, Gap</p>
<p><b>Remarks</b> Overall Interior - Smell - Yes / Rear Seat - Grime - Medium / (R) Front Seat - Grime - Medium / (L) Front Seat - Grime - Medium / Ceiling - Grime - Small / Console, Switches, Vents - Traces of Adhesive Tape - Yes / (L) Front Floor Mat - Worked - Small / (R) Front Trim - Grime - Minimal / (L) Front Trim - Grime - Minimal</p>	<p><b>Remarks</b> (R) Front Door - Repair Traces - Yes / (R) Front Fender - Repair Traces - Yes / Bonnet - Repair Traces - Yes / (L) Rear Door - Repair Traces - Yes / (L) Rear Fender - Repair Traces - Yes / Trunk Hood, Rear Gate - Repair Traces - Yes / (R) Rear Fender - Repair Traces - Yes / (R) Rear Door - Repair Traces - Yes / Roof - Repair Traces - Yes / (R) Front Fender, Molding - Repair mark - Difference in Color / (R) Front Door, Molding - Repair mark - Difference in Color / (R) Rear Door, Molding - Repair mark - Difference in Color / (R) Rear Fender, Molding - Repair mark - Difference in Color / Front Bumper, Grille, Lamps - Repair mark - Difference in Color / (R) Front Door, Molding - Scratch - Medium / (R) Front Fender, Molding - Scratch - Minimal / (R) Step, In-panel, Side Spoiler - Scratch &amp; Dent - Small / (R) Rear Fender, Molding - Scratch - Small / (R) Rear Door, Molding - Scratch - Minimal / Rear Bumper, Lamps, Panels - Repair mark - Difference in Color / Rear Bumper, Lamps, Panels - Scratch - Small / Trunk Hood, Rear Gate - Scratch - Small / (L) Rear Fender, Molding - Scratch - Minimal / (L) Rear Door, Molding - Scratch - Small / (L) Front Door, Molding - Scratch - Minimal / (L) Mirror - Scratch - Small / (L) Front Fender, Molding - Scratch &amp; Dent - Minimal / Front Bumper, Grille, Lamps - Scratch - Small / Bonnet, Headlight - Repair mark - Yes / Bonnet, Headlight - Scratch - Small / Roof - Scratch - Small</p>
