## General Information

<b>Make</b>	Toyota	<b>Model</b>	Vios
<b>YOM</b>	2024	<b>Odo Meter Reading</b>	20,812
<b>Registration No.</b>	DBM4649	<b>Chassis No.</b>	PA1B18F34R4243181
<b>CC</b>	1.3	<b>Transmission</b>	CVT
<b>Fuel Type</b>	Gas	<b>Type of Body</b>	Sedan
<b>Colour</b>	Red Mica Metallic

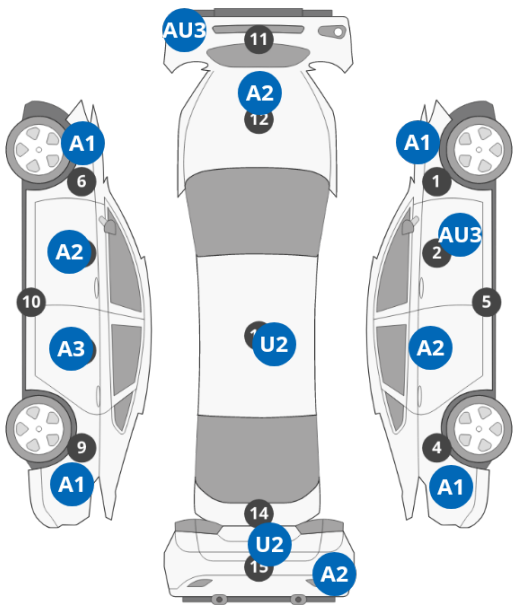
<p><b>A</b> : Scratch <b>AU</b> : Scratch &amp; Dent <b>B</b> : Modified <b>C</b> : Corrosion <b>G</b> : Stone chip <b>P</b> : Faded <b>S</b> : Rust <b>SC</b> : Rust &amp; Corrosion <b>U</b> : Dent <b>X</b> : Defective <b>Y</b> : Crack, Gap</p>
<p><b>Remarks</b> Trunk Room - Worn, Scratch, Cut, Crack - Small / Rear Seat - Grime - Large / (R) Front Trim - Grime - Medium / (R) Front Seat - Grime - Medium / (L) Front Trim - Grime - Medium / (L) Front Seat - Grime - Medium / Dashboard - Worn, Scratch, Cut, Crack - Small / Ceiling - Grime - Minimal</p>	<p><b>Remarks</b> Roof - Dent - Small / (L) Rear Door, Molding - Scratch - Medium / (L) Front Door, Molding - Scratch - Small / (L) Front Fender, Molding - Scratch - Minimal / Bonnet, Headlight - Scratch - Small / Front Bumper, Grille, Lamps - Scratch &amp; Dent - Medium / (R) Front Fender, Molding - Scratch - Minimal / (R) Front Door, Molding - Scratch &amp; Dent - Medium / (R) Rear Door, Molding - Scratch - Small / (R) Rear Fender, Molding - Scratch - Minimal / Trunk Hood, Rear Gate - Dent - Small / Rear Bumper, Lamps, Panels - Scratch - Small / (L) Rear Fender, Molding - Scratch - Minimal</p>
