General Information

Make	Toyota	Model	Avanza
YOM	2023	Odo Meter Reading	144,508
Registration No.	NHC9586	Chassis No.	MHFAA1BY7N0010837
CC	1.3	Transmission	CVT
Fuel Type	Gas	Type of Body	MPV
Colour	Green

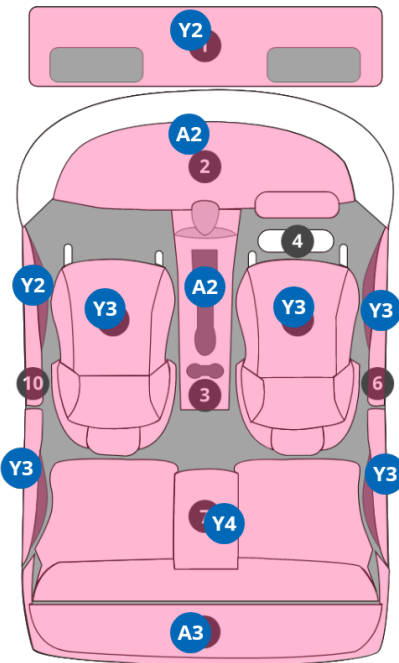
Interior Evaluation : E	Exterior Evaluation : C

<p>a : Cut, Fray d : Loose, Deformed k : Animal Hair s : Smell t : Cigarette Burns x : Defective y : Stain</p>

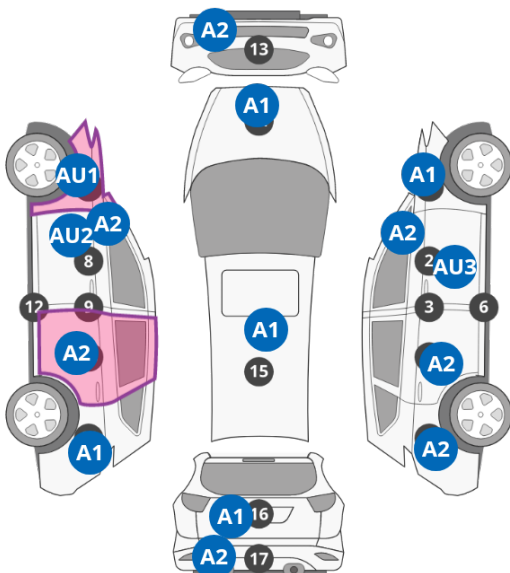
<p>A : Scratch AU : Scratch & Dent B : Modified C : Corrosion G : Stone chip P : Faded S : Rust SC : Rust & Corrosion U : Dent X : Defective Y : Crack, Gap</p>
Remarks Rear Seat - Grime - Large / (R) Front Trim - Grime - Medium / (R) Front Seat - Grime - Medium / (R) Rear Trim - Grime - Medium / Trunk Room - Worn, Scratch, Cut, Crack - Medium / (L) Rear Trim - Grime - Medium / (L) Front Seat - Grime - Medium / (L) Front Trim - Grime - Small / Console, Switches, Vents - Worn, Scratch, Cut, Crack - Small / Dashboard - Worn, Scratch, Cut, Crack - Small / Ceiling - Grime - Small	Remarks (L) Front Fender - Repair Traces - Yes / (L) Rear Door - Repair Traces - Yes / (L) Front Fender, Molding - Scratch & Dent - Minimal / (L) Mirror - Scratch - Small / (L) Front Door, Molding - Scratch & Dent - Small / (L) Rear Door, Molding - Repair mark - Yes / (L) Rear Door, Molding - Scratch - Small / (L) Front Fender, Molding - Repair mark - Yes / (L) Rear Fender, Molding - Scratch - Minimal / Rear Bumper, Lamps, Panels - Scratch - Small / Trunk Hood, Rear Gate - Scratch - Minimal / (R) Rear Fender, Molding - Scratch - Small / (R) Rear Door, Molding - Scratch - Small / (R) Front Door, Molding - Scratch & Dent - Medium / (R) Mirror - Scratch - Small / Bonnet, Headlight - Scratch - Minimal / Front Bumper, Grille, Lamps - Scratch - Small / (R) Front Fender, Molding - Scratch - Minimal / Roof - Scratch - Minimal
