## General Information

<b>Make</b>	Toyota	<b>Model</b>	Vios
<b>YOM</b>	2023	<b>Odo Meter Reading</b>	73,447
<b>Registration No.</b>	NHR1012	<b>Chassis No.</b>	PA1B18F38P4219088
<b>CC</b>	1.3	<b>Transmission</b>	CVT
<b>Fuel Type</b>	Gas	<b>Type of Body</b>	Sedan
<b>Colour</b>	Black

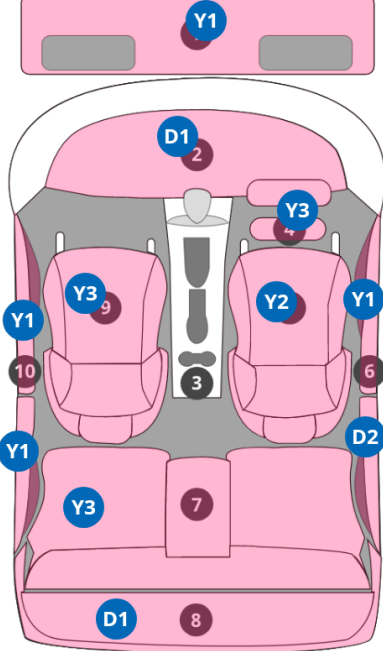
<p><b>a</b> : Cut, Fray <b>d</b> : Loose, Deformed <b>k</b> : Animal Hair <b>s</b> : Smell <b>t</b> : Cigarette Burns <b>x</b> : Defective <b>y</b> : Stain</p>

<p><b>A</b> : Scratch <b>AU</b> : Scratch &amp; Dent <b>B</b> : Modified <b>C</b> : Corrosion <b>G</b> : Stone chip <b>P</b> : Faded <b>S</b> : Rust <b>SC</b> : Rust &amp; Corrosion <b>U</b> : Dent <b>X</b> : Defective <b>Y</b> : Crack, Gap</p>
<b>Remarks</b> (L) Front Seat - Grime - Medium / Rear Seat - Grime - Medium / (L) Front Floor Mat - Grime - Medium / Dashboard - Worked - Minimal / Ceiling - Grime - Minimal / (L) Front Trim - Grime - Minimal / (R) Rear Trim - Worked - Small / (R) Front Trim - Grime - Minimal / (L) Rear Trim - Grime - Minimal / (R) Front Seat - Grime - Small / Trunk Room - Worked - Minimal	<b>Remarks</b> Bonnet - Repair Traces - Yes / Rear Bumper, Lamps, Panels - Scratch & Dent - Medium / Trunk Hood, Rear Gate - Scratch & Dent - Small / (L) Rear Fender, Molding - Scratch & Dent - Large / (L) Rear Door, Molding - Scratch & Dent - Medium / (L) Front Door, Molding - Scratch & Dent - Small / Roof - Scratch & Dent - Small / (L) Front Fender, Molding - Scratch & Dent - Small / Bonnet, Headlight - Scratch & Dent - Small / Front Bumper, Grille, Lamps - Scratch - Medium / (R) Front Fender, Molding - Scratch & Dent - Medium / (R) Front Door, Molding - Scratch - Small / (R) Rear Door, Molding - Scratch - Large / (R) Step, In-panel, Side Spoiler - Scratch & Dent - Minimal / (R) Rear Fender, Molding - Scratch & Dent - Small / (L) Step, In-panel, Side Spoiler - Scratch & Dent - Small / (L) Mirror - Scratch - Minimal
