General Information

Make	Toyota	Model	Wigo
YOM	2023	Odo Meter Reading	10,072
Registration No.	NII5314	Chassis No.	MHKA4DF5FNJ077782
CC	1.0	Transmission	A/T
Fuel Type	Gas	Type of Body	Hatchback
Colour	Gray

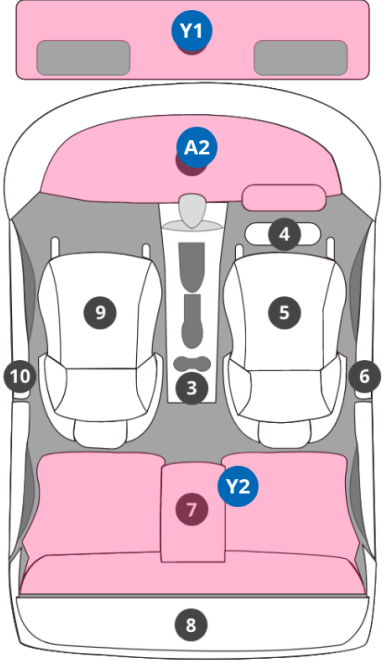
Interior Evaluation : A	Exterior Evaluation : D

<p>a : Cut, Fray d : Loose, Deformed k : Animal Hair s : Smell t : Cigarette Burns x : Defective y : Stain</p>

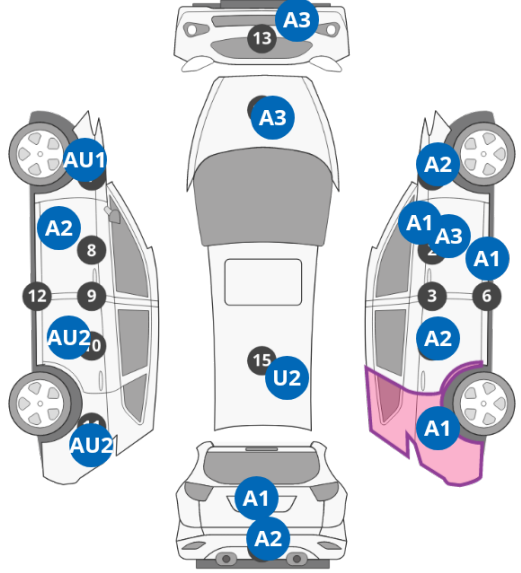
<p>A : Scratch AU : Scratch & Dent B : Modified C : Corrosion G : Stone chip P : Faded S : Rust SC : Rust & Corrosion U : Dent X : Defective Y : Crack, Gap</p>
Remarks Rear Seat - Grime - Small / Ceiling - Grime - Minimal / Dashboard - Worn, Scratch, Cut, Crack - Small	Remarks Bonnet - Repair Traces - Yes / (L) Front Door - Repair Traces - Yes / (L) Rear Fender - Repair Traces - Yes / Trunk Hood, Rear Gate - Repair Traces - Yes / (R) Rear Fender - Repair Traces - Yes / Roof - Repair Traces - Yes / (R) Rear Fender, Molding - Repair mark - Yes / Roof - Dent - Small / (L) Rear Fender, Molding - Scratch & Dent - Small / (L) Rear Door, Molding - Scratch & Dent - Small / (L) Front Door, Molding - Scratch - Small / (L) Front Fender, Molding - Scratch & Dent - Minimal / Front Bumper, Grille, Lamps - Scratch - Medium / Bonnet, Headlight - Scratch - Medium / (R) Front Fender, Molding - Scratch - Small / (R) Front Door, Molding - Scratch - Medium / (R) Rear Fender, Molding - Scratch - Minimal / (R) Mirror - Scratch - Minimal / Trunk Hood, Rear Gate - Scratch - Minimal / Rear Bumper, Lamps, Panels - Scratch - Small / (R) Rear Door, Molding - Scratch - Small / (R) Step, In-panel, Side Spoiler - Scratch - Minimal
